FUNCTIONAL ASSESSMENT OF THE MANCOS RIVER WATERSHED:

MANCOS VALLEY AND ADJACENT AREAS

PETER STACEY
UNIVERSITY OF NEW MEXICO

Prepared Under Contract with the
Mancos Conservation District
Mancos, Colorado
April, 2007

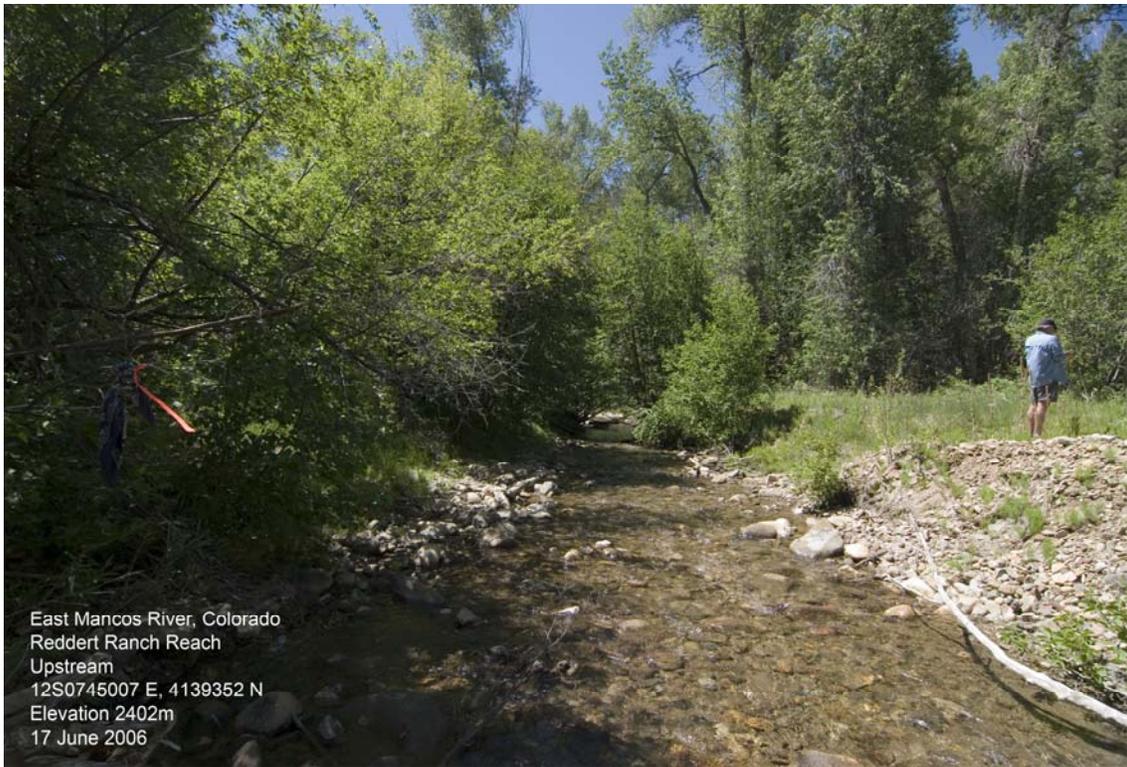
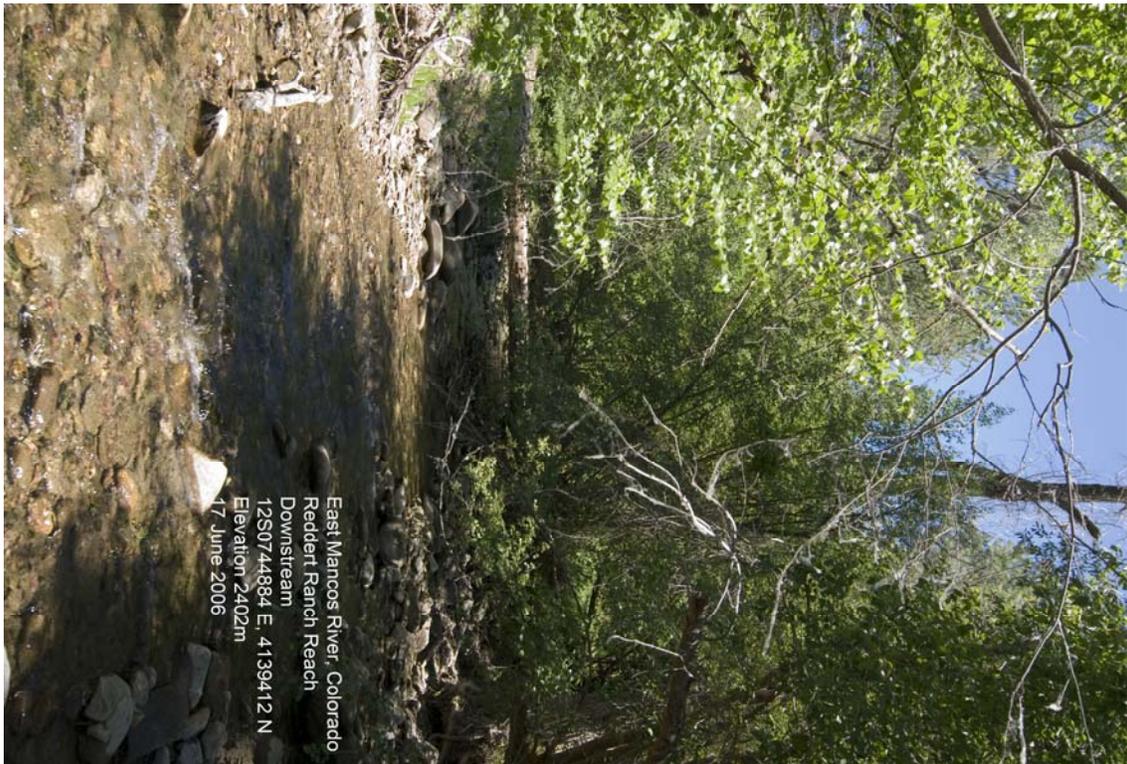
Figure 5. Reference Photos for the upstream and downstream ends of the Reddert Ranch Reach, East Mancos River.

The reach is generally in good to excellent condition, with some exceptions. Nonchemical Water Quality was good, with the expected amount of algae, and with dense overhanging vegetation providing good solar shading. Hydrogeomorphology was generally very good, although the channel was incised more than what would be expected, suggesting that there have been high flow events in the past that have produced some downcutting. There appears to be little active erosion at present. There are no beavers in the assessment reach, but there is an active colony just across the road at the mouth of the Middle Mancos. It is likely these beavers will colonize the area in the near future, if not removed by humans.

Fish/Aquatic Habitat was uniformly excellent, with the exception that there was no macroinvertebrate fauna found in the stream. In addition, no fish were observed during the assessment, despite the fact that this is excellent habitat, and that fish are found in the Middle Mancos where it joins the East Mancos. This indicates that there is probably something in the water that is killing the insects, and this should be examined in greater detail by more detailed chemical studies (see also note to West Mancos-Weber Diversion assessment, below).

Riparian Vegetation and Terrestrial Wildlife Habitat was generally good to very good. There was a lack of shrub cover in much of the reach. This may be due to the heavy browsing levels that were observed on shrubs and small trees. There was little evidence of current livestock use, which suggests that most browsing at present is from mule deer and elk.

Non-native herbaceous plant cover was high, but there were no non-native shrubs or trees found in the reach.

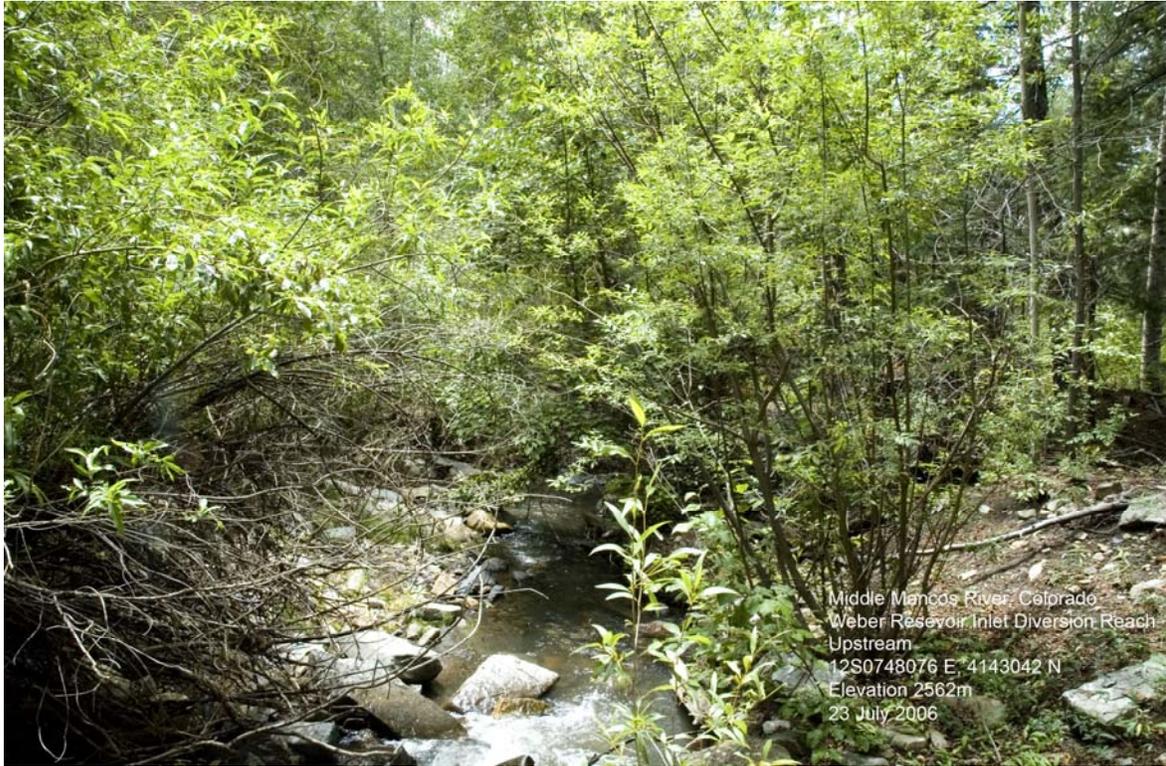
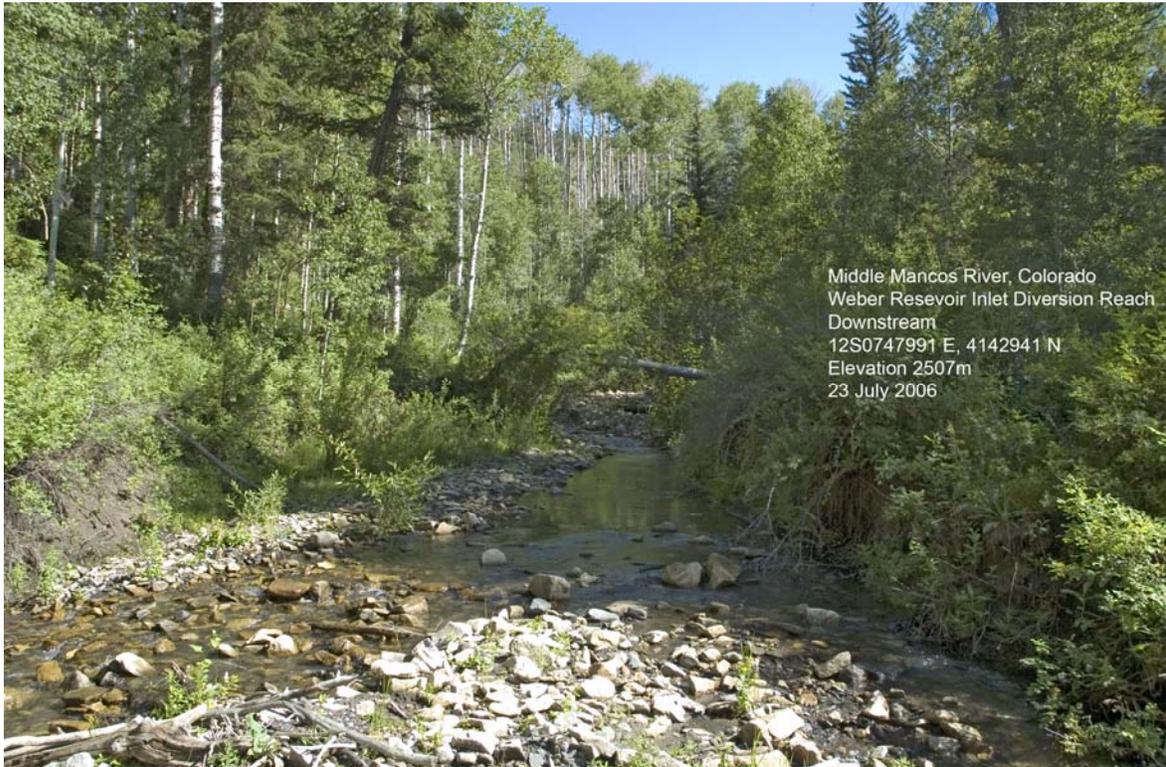
Figure 7. References Photos for the Weber Reservoir Inlet Diversion Reach, Middle Mancos River.

This reach is in excellent condition overall and can serve as a reference reach for similar size and gradient streams in this elevation range in the Mancos Watershed.

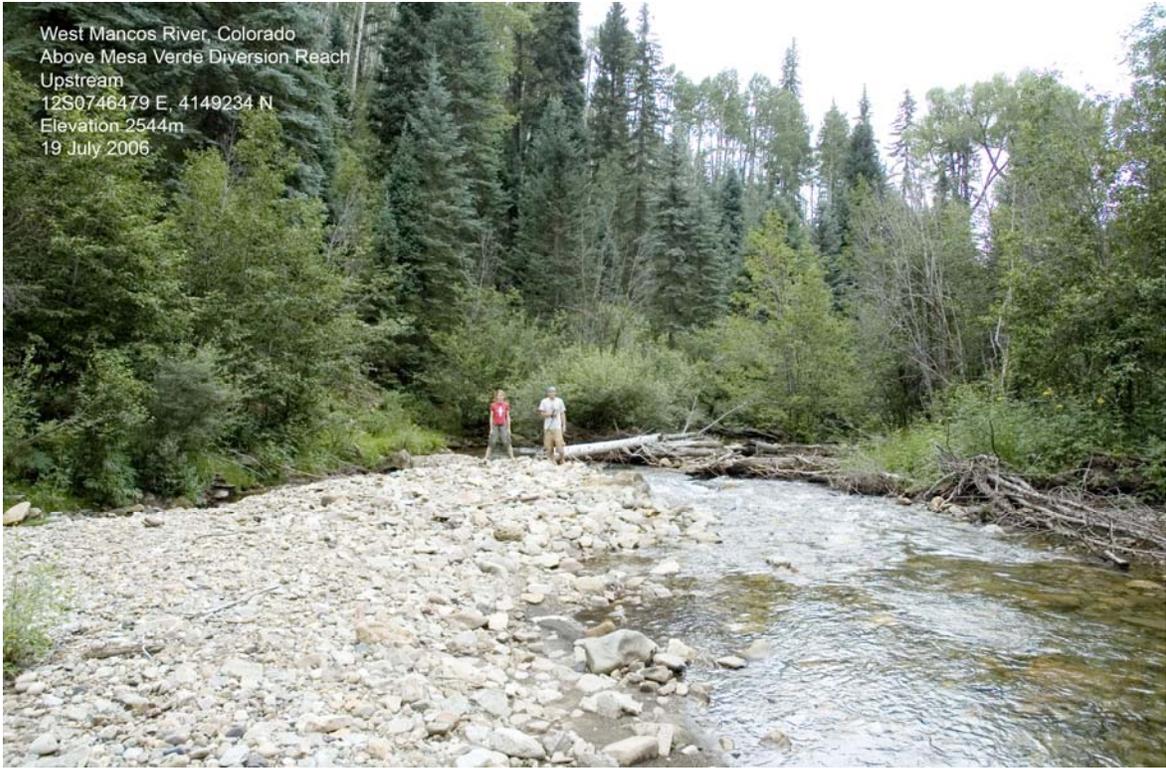
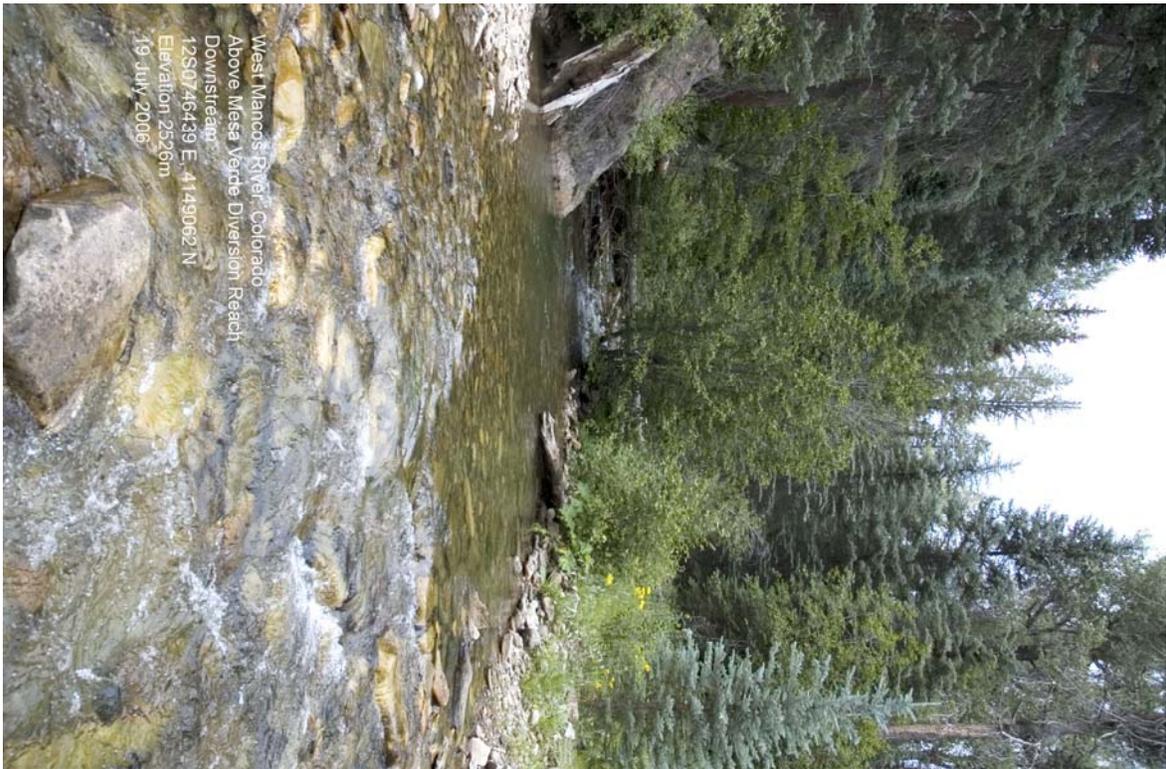
Figure 9. Reference Photos for the Above Mesa Verde Diversion Reach, West Mancos River.

Nonchemical Water Quality was good, although there was only moderate stream shading. This probably has only a minor impact on water temperatures, given the elevation of the stream and its gradient. Hydrogeomorphology was generally very good to excellent, except that the channel is isolated from the floodplain. The reason for this is not clear. There are no levees along the stream channel as is observed further downstream. This situation may be due to past episodes of heavy livestock grazing combined with exceptionally high flow events, but this remains speculation. There were no beavers on the reach. Their presence would have a significant positive impact on the ecosystem.

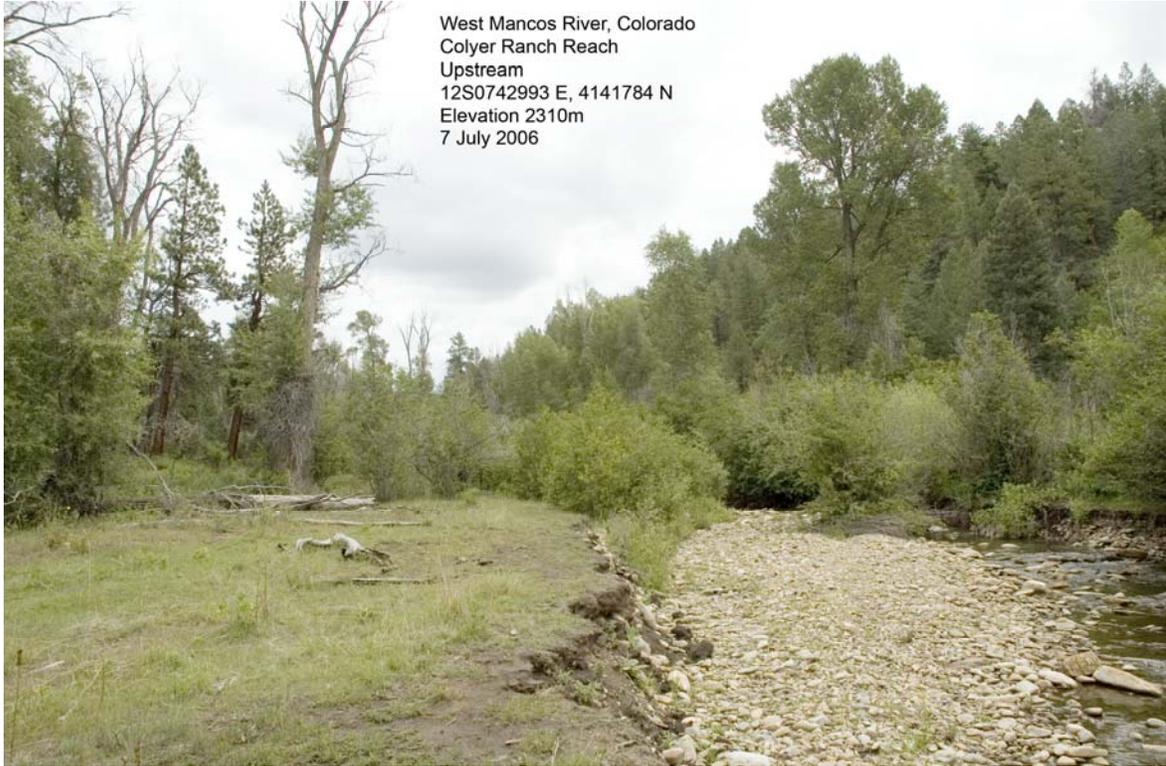
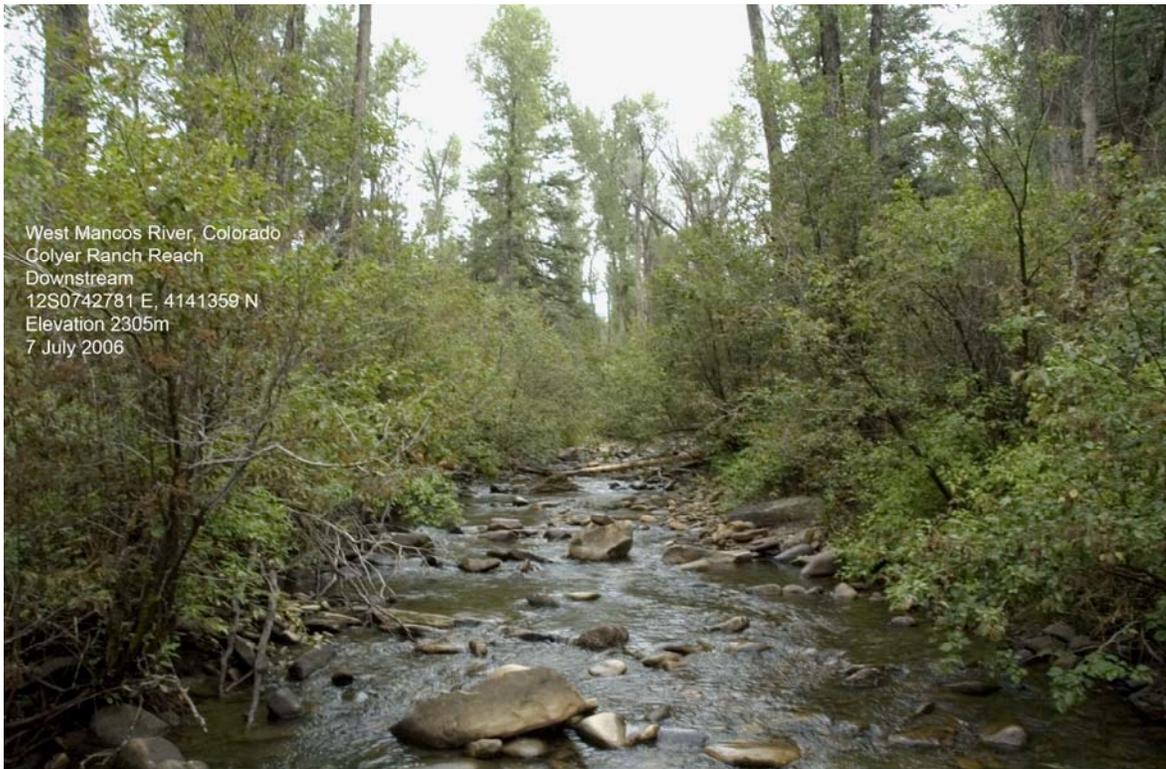
Figure 13. Reference Photos for the Colyer Ranch Reach, West Mancos River.

Algal growth was high in this section relative to the reaches further upstream, leading to a rating of fair. Cow manure was observed in the stream itself, suggesting there is nutrient loading in this reach from livestock use. Channel shading, in contrast, was very good.

Riparian Vegetation was generally very good. The only issues were the lack of vegetative cover in the lower riparian zone, which was the result of the levees, and the levels of grazing (only good) and browsing by livestock and deer and elk (poor). Sixty-three per cent of the shrubs and small trees had been browsed in the sample transect. This level of browsing could lead to a failure in the recruitment of new shrubs and trees in the riparian zone along this reach in the future.

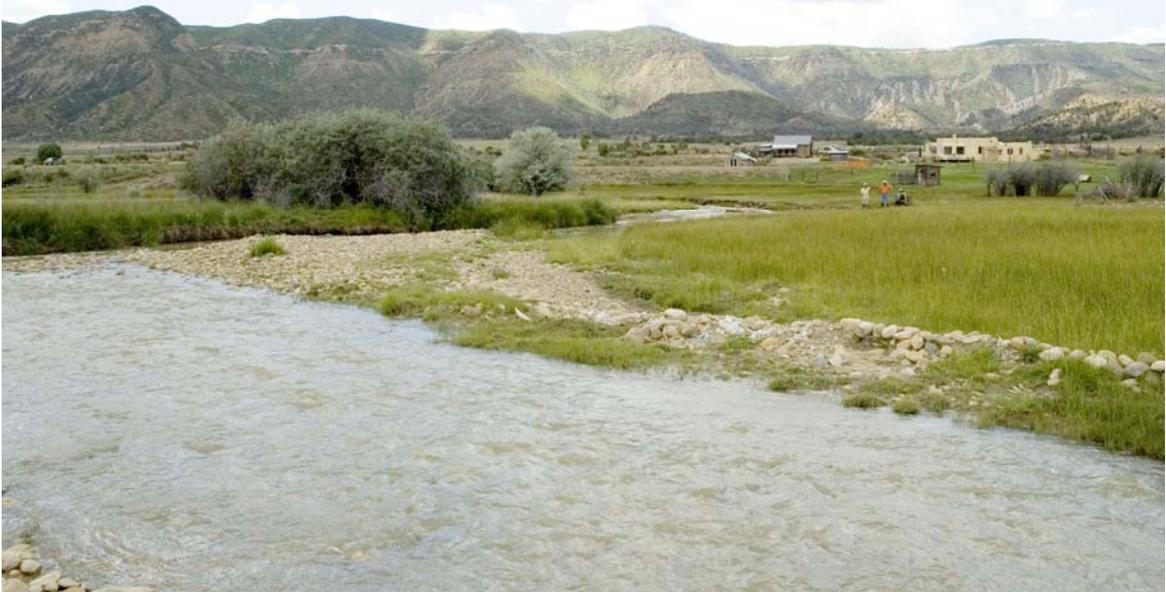
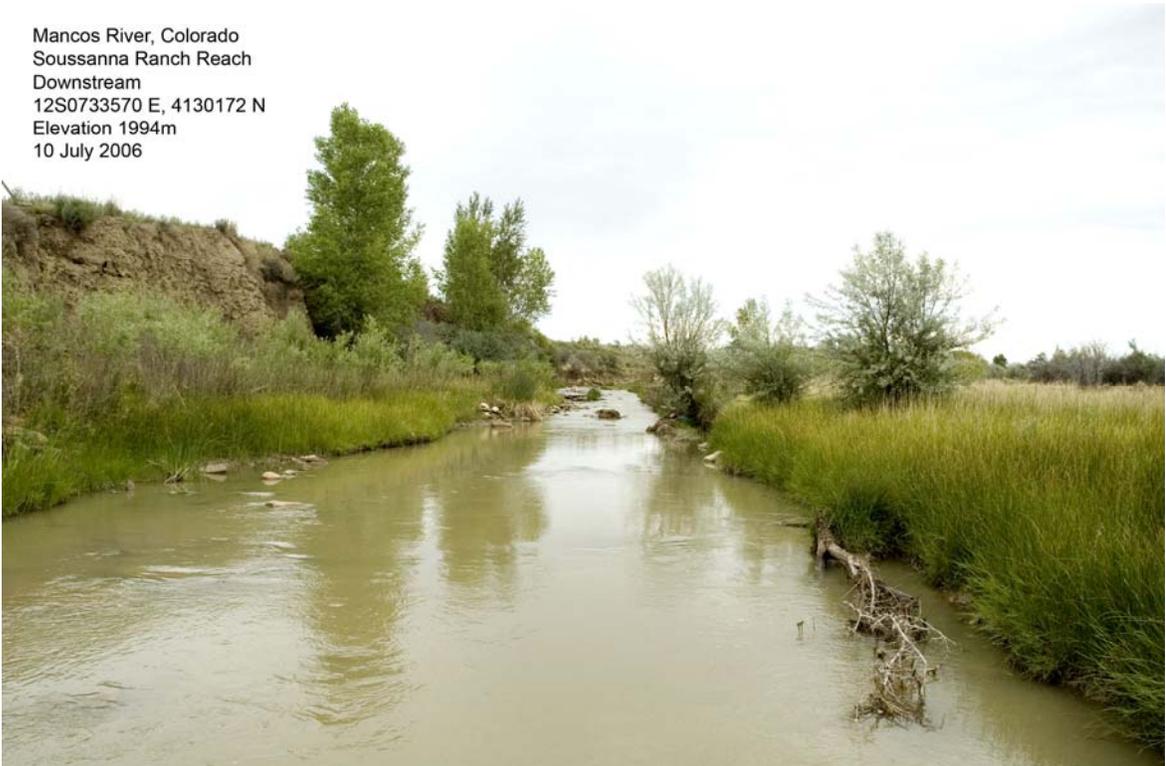
Figure 29. Reference Photos for the Soussanna Ranch Reach, Mancos River.

Mancos River, Colorado
Soussanna Ranch Reach
Upstream
12S0733603 E, 4130540 N
Elevation 1999m
10 July 2006

Mancos River, Colorado
Soussanna Ranch Reach
Downstream
12S0733570 E, 4130172 N
Elevation 1994m
10 July 2006

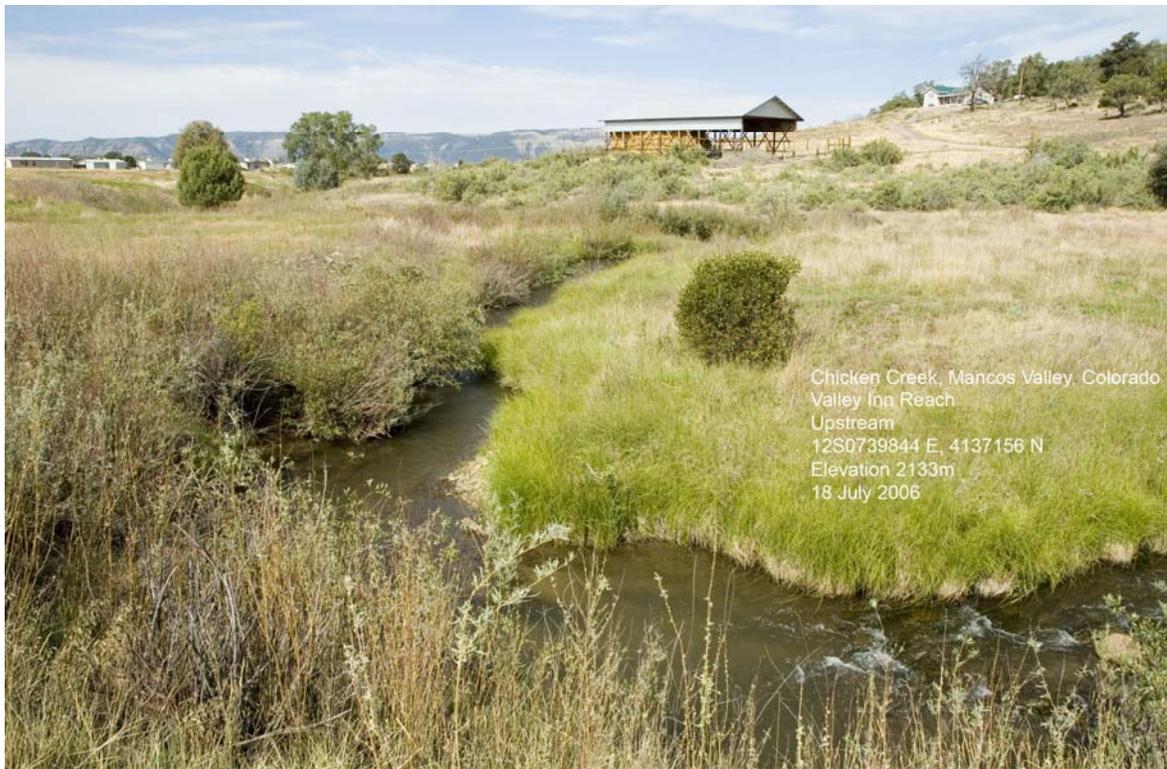
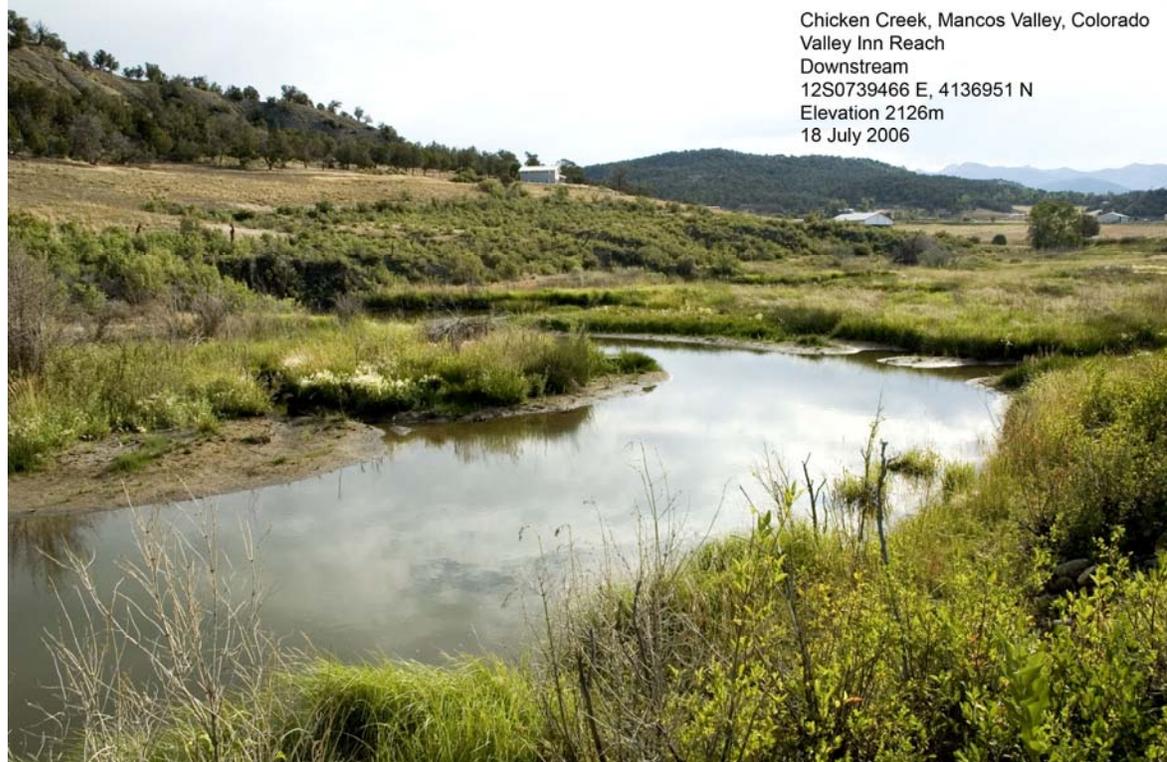
Figure 35. References Photos for Valley Inn Reach, Chicken Creek.

Chicken Creek, Mancos Valley, Colorado
Valley Inn Reach
Upstream
12S0739844 E, 4137156 N
Elevation 2133m
18 July 2006

Chicken Creek, Mancos Valley, Colorado
Valley Inn Reach
Downstream
12S0739466 E, 4136951 N
Elevation 2126m
18 July 2006

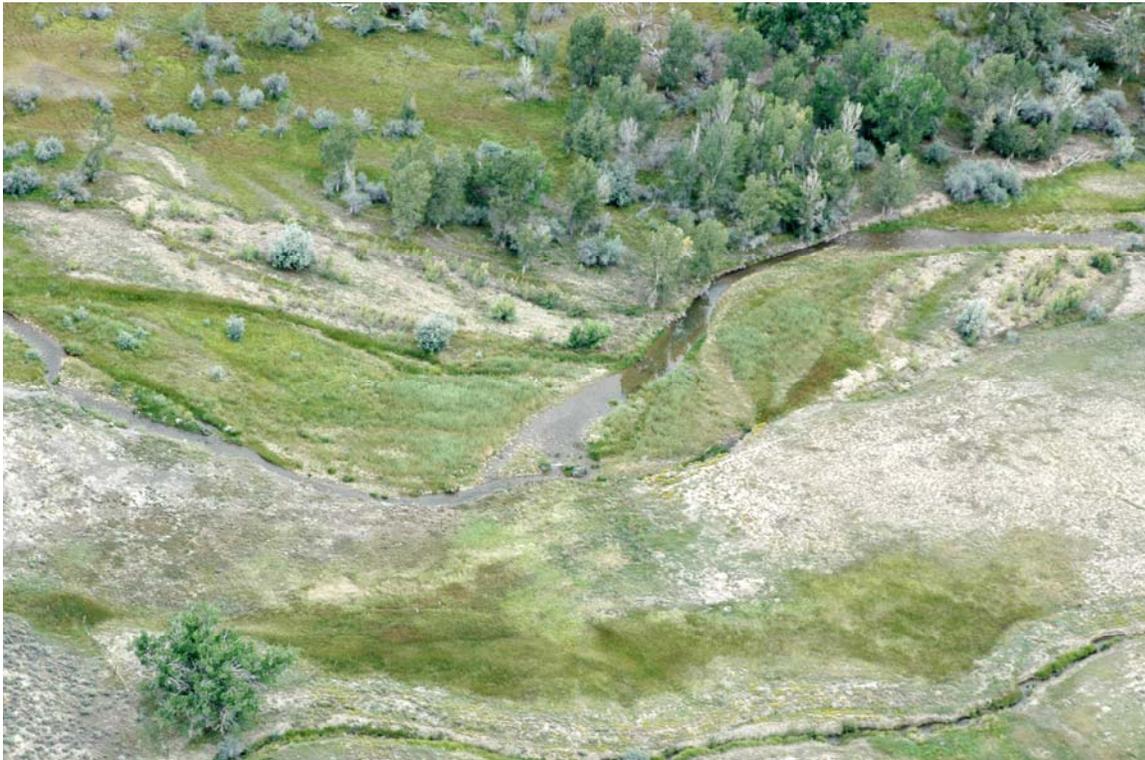
Figure 78. An illustration of the role played by leakage from unlined irrigation ditches in maintaining moist conditions throughout the riparian zone of the Mancos River in Mancos Valley. The wet meadow at the bottom of the picture is located in the upper and normally drier part of the flood plain. However, it is present because of water leaking from the ditch that runs just above it. The river in this reach (Perry Ranch) is not channelized and does not have levees. As a result, there are also the wet areas that would normally be expected to be present immediately adjacent to the stream, and which result from both overbank flooding and underground water flowing next to the channel. Between the two wet areas is a dry zone with very little vegetation (*photo by Pete Crusier*).
