FUNCTIONAL ASSESSMENT OF THE MANCOS RIVER WATERSHED:

MANCOS VALLEY AND ADJACENT AREAS

PETER STACEY
UNIVERSITY OF NEW MEXICO

Prepared Under Contract with the
Mancos Conservation District
Mancos, Colorado
April, 2007

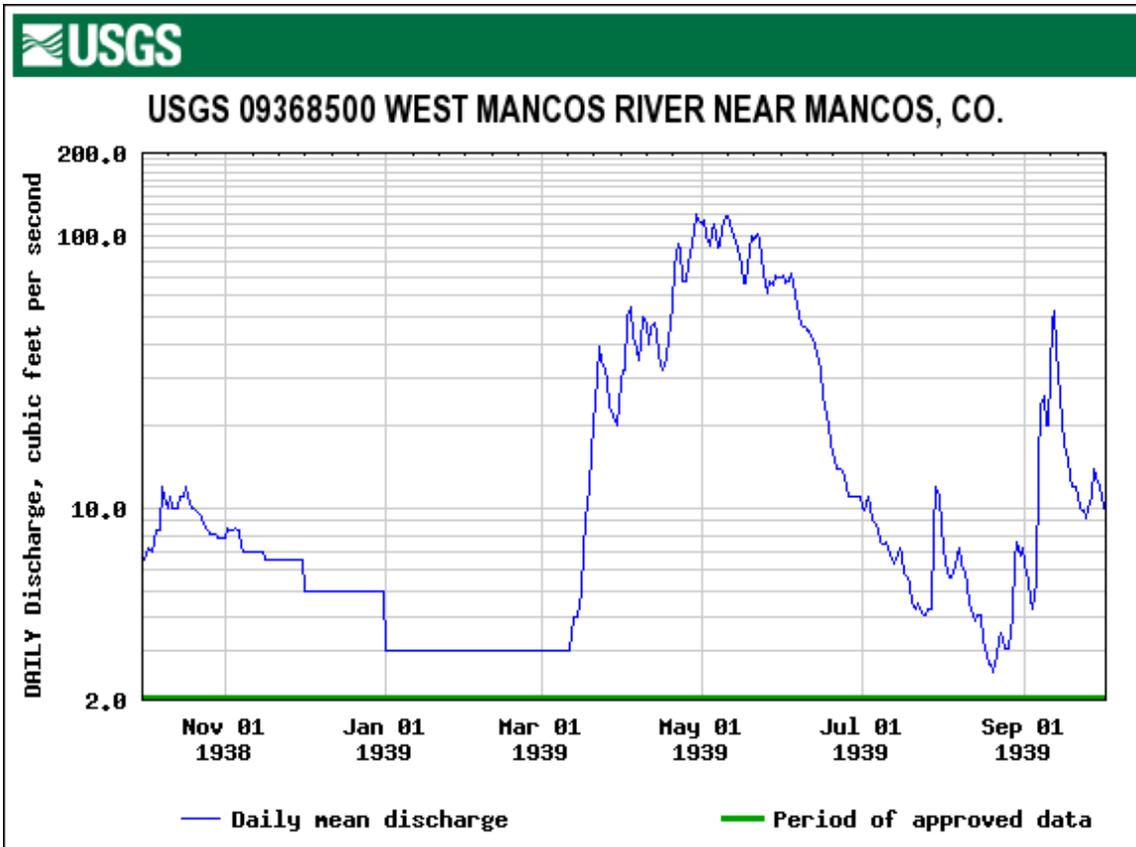
Without further detailed analysis, it is impossible to know what the overall impact of the irrigation removals and water storage reservoirs has been on the stream-riparian ecosystems within the study area. The primary effect of the diversions is to decrease the total amount of water in reaches downstream whenever the diversion is active. A secondary effect, from the storage reservoir part of the irrigation system, is to decrease the annual variance in water flow. Part of the spring run off is captured by the reservoir, which then decreases the natural peak of water flow during that time. This stored water is then released throughout the summer, increasing the amount of water in at least parts of the river over what would normally be present (above any diversion of that water into irrigation ditches). It is impossible to tell how much of the hydrograph pattern in Figure 3 has been altered due to the combined effects of water

Figure 3. Hydrograph from the West Mancos River in 1939, prior to the construction of Jackson Gulch Reservoir, which was completed in 1949. The hydrograph shows an annual pattern in stream flow levels typical of many streams and small rivers in the southwest, with the highest flows during the spring snow melt, and a secondary peak during the summer rainy season. Low flows occur during the winter months, and during mid to late summer before the summer rains. The watershed area of the West Mancos River that feeds into the measured water flow location in this figure is 42 square miles, and has an average discharge of 27,490 acre feet per year (USBR, 2007).

storage and diversion. However, overall, these factors are likely to have the following impacts: 1) reduce the peak amount of water that flows in downstream reaches, particularly the scouring flows and overbank flooding that often occur during the spring run-off, and 2) reduce the total amount of water that flows in the furthest downstream reaches during the water diversion/irrigation season, although this might be balanced to some extent in some reaches by water releases and irrigation ditch return flows during the period of low precipitation in the early summer. The Mancos watershed, particularly the upper part, is relatively small; whether or not any of the reaches in Mancos Valley and surrounding areas ever went totally dry before the development of intensive irrigation remains problematic.

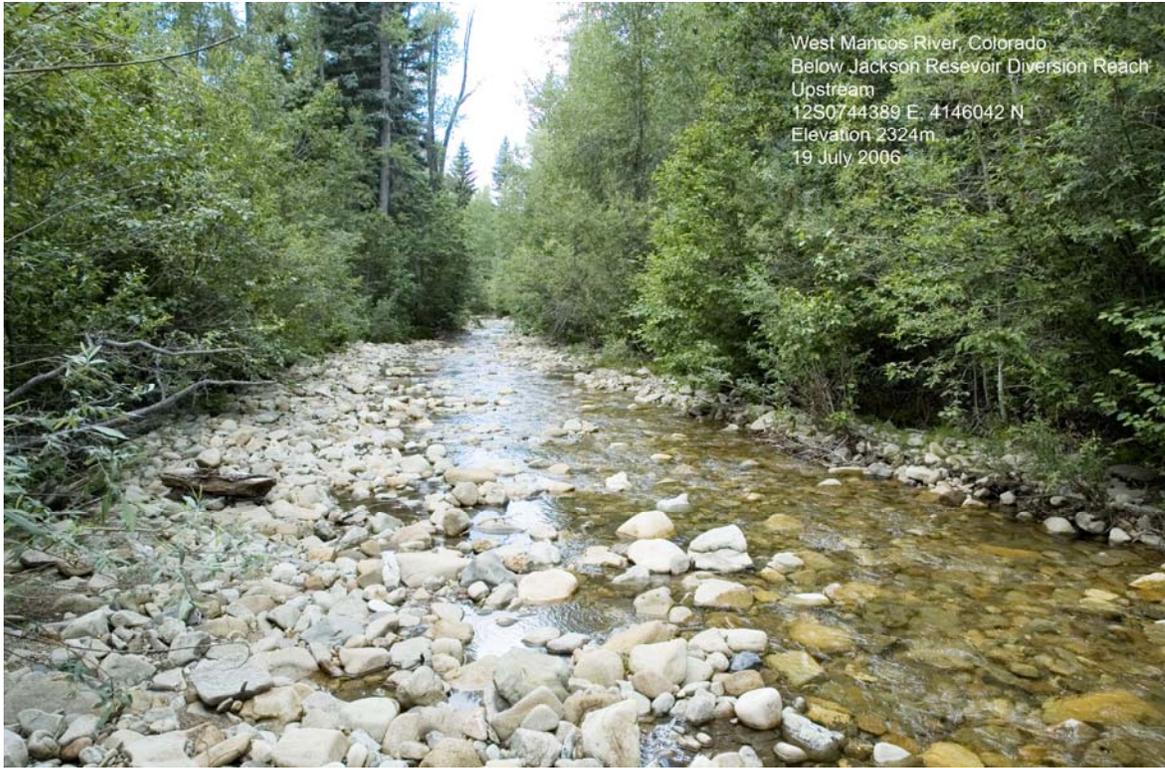
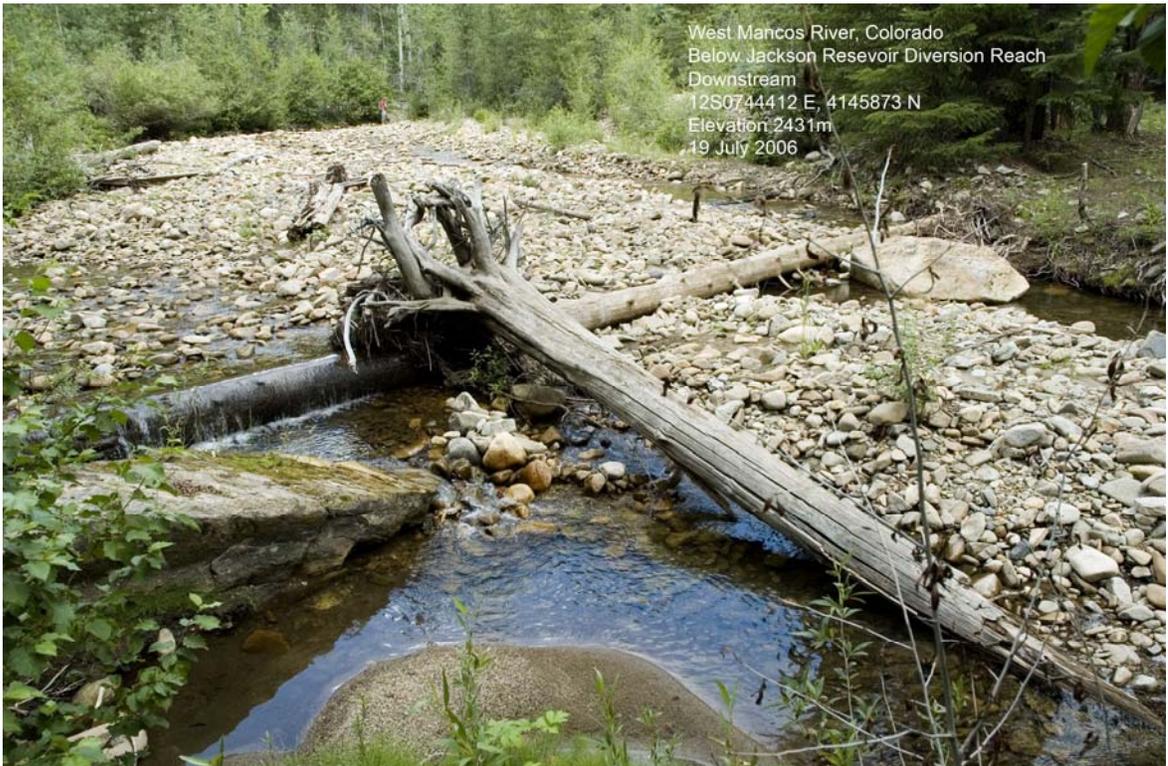
Figure 11. Reference photos for the Below Jackson Reservoir Diversion Reach, West Mancos River. The Mesa Verde diversion pipeline crosses the stream channel in the lower

In the Hydrogeomorphology section, this reach received a poor rating for floodplain connection. This was due to the presence of a levee on the east side of the channel that resulted from the construction of the Mesa Verde Pipeline, and isolated the stream from its floodplain in this section. The stream channel itself is wide and shallow, also probably the result of pipeline construction. As a result, hydraulic habitat diversity was only good. However, where the pipeline was located away from the channel, below the assessment reach, hydraulic habitat diversity became excellent, and as would be expected for this geomorphic setting. Vertical bank stability and riparian soil integrity was excellent through the entire reach, reflecting the absence of livestock grazing, roads, or other impacts. There are no beavers in this reach, although the habitat would be suitable for them.

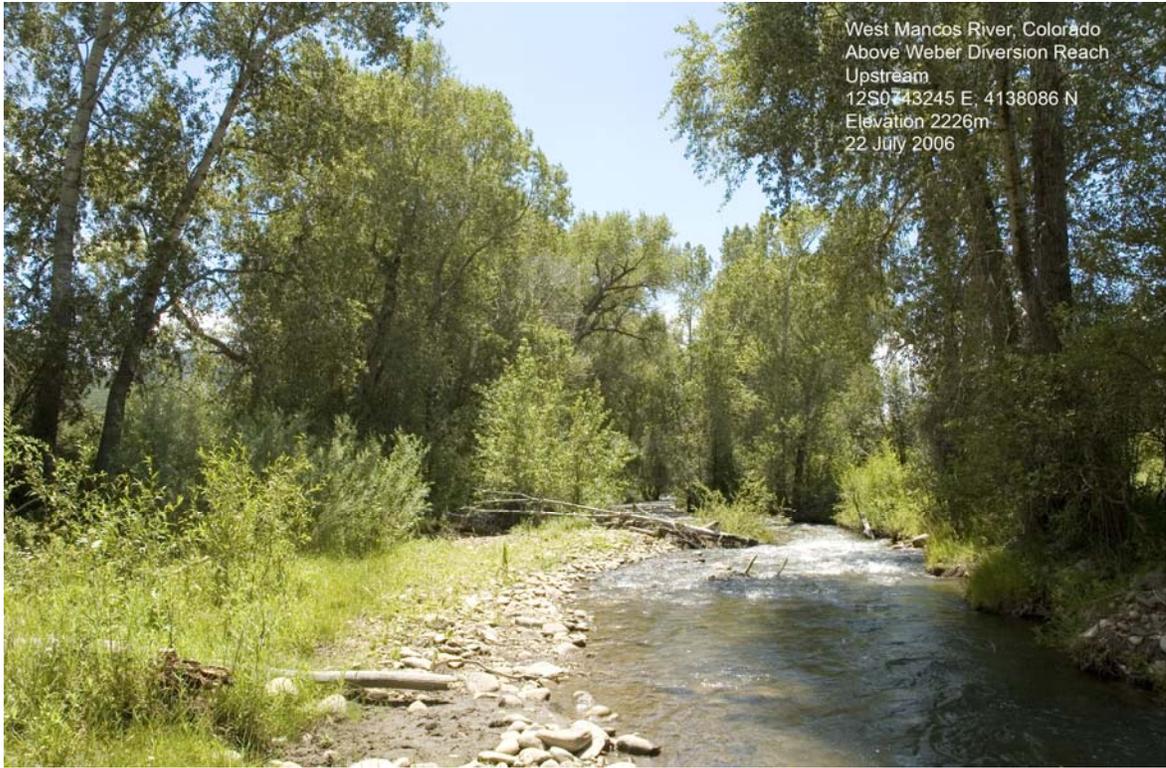
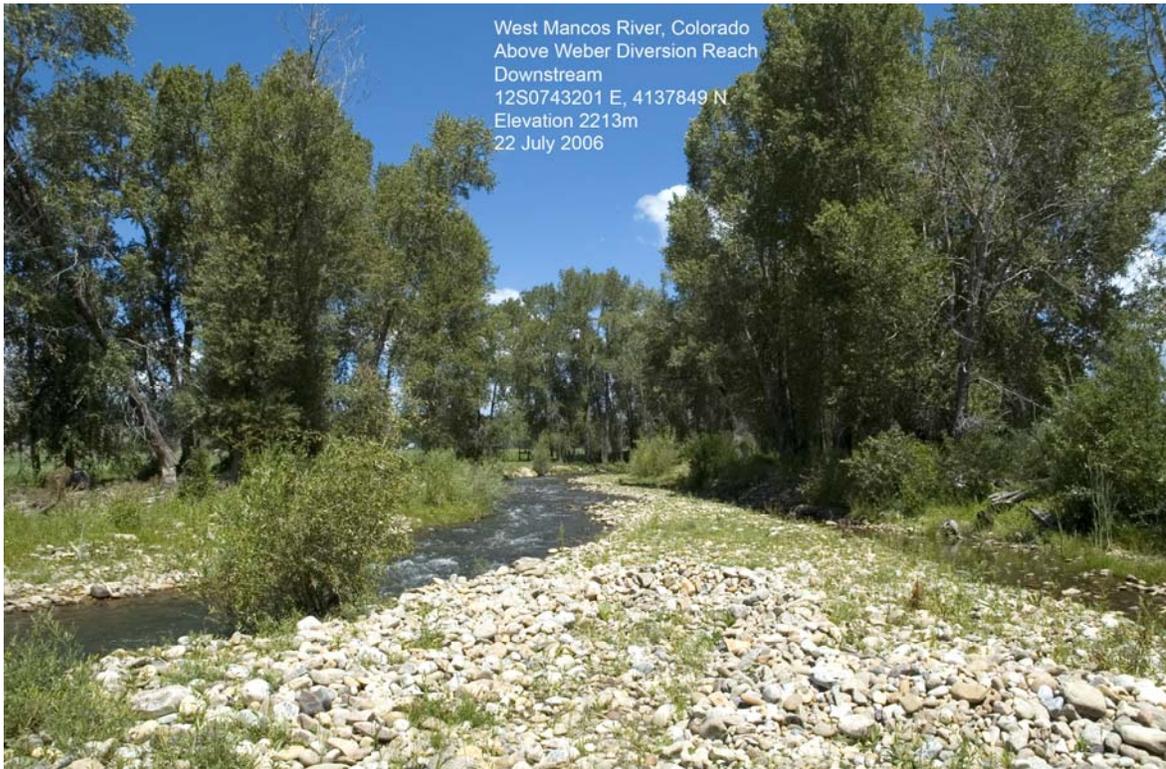
Figure 15. Reference Photos for the Above Weber Diversion Reach, Mancos River.

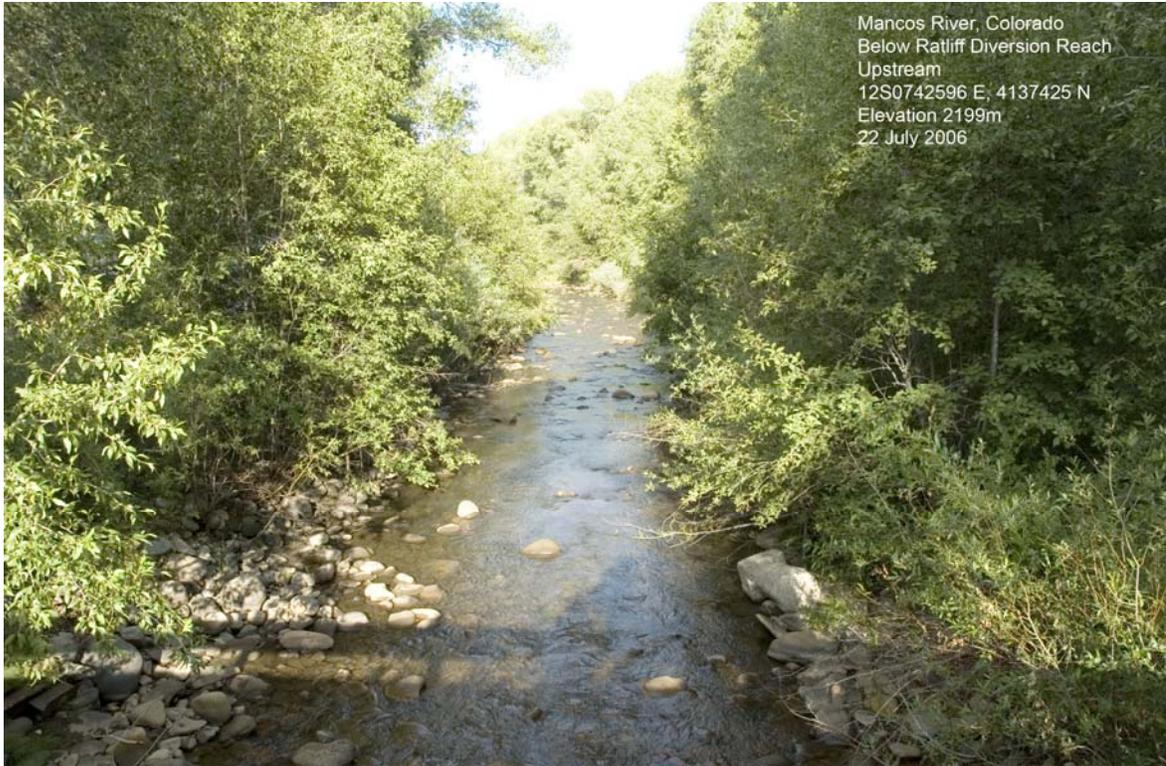
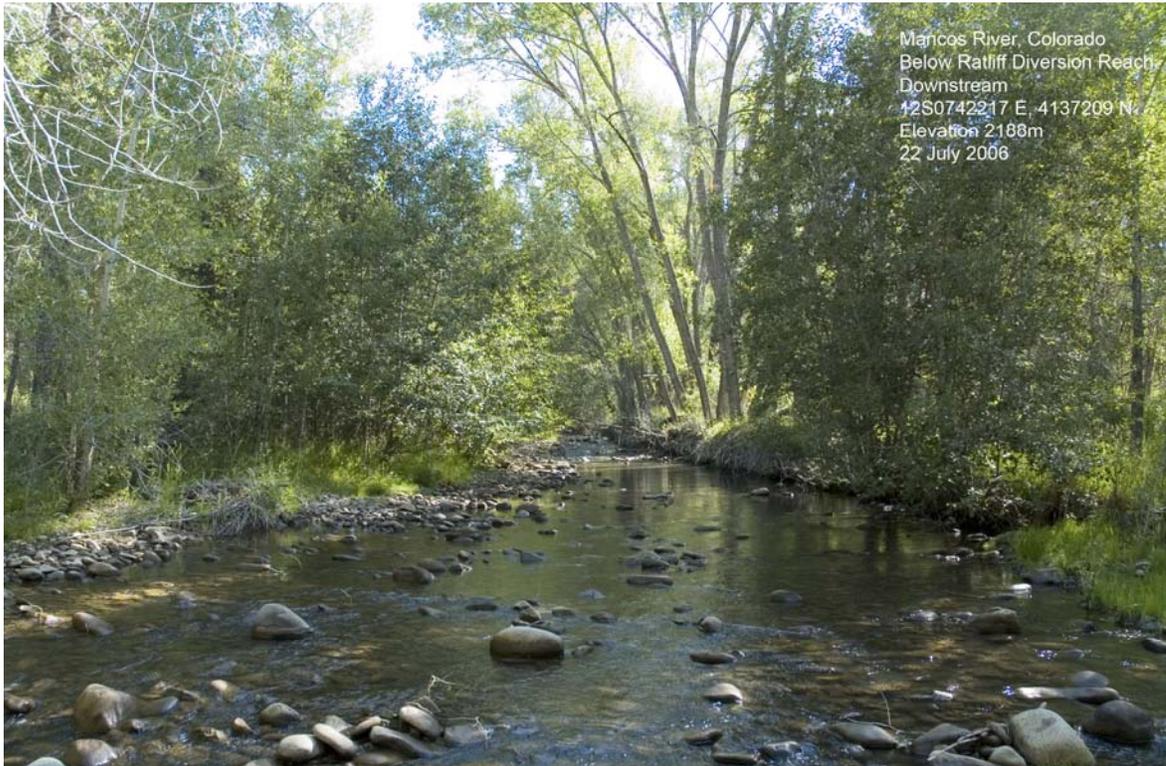
Figure 17. Reference Photos for the Below Ratliff Diversion Reach, Mancos River.

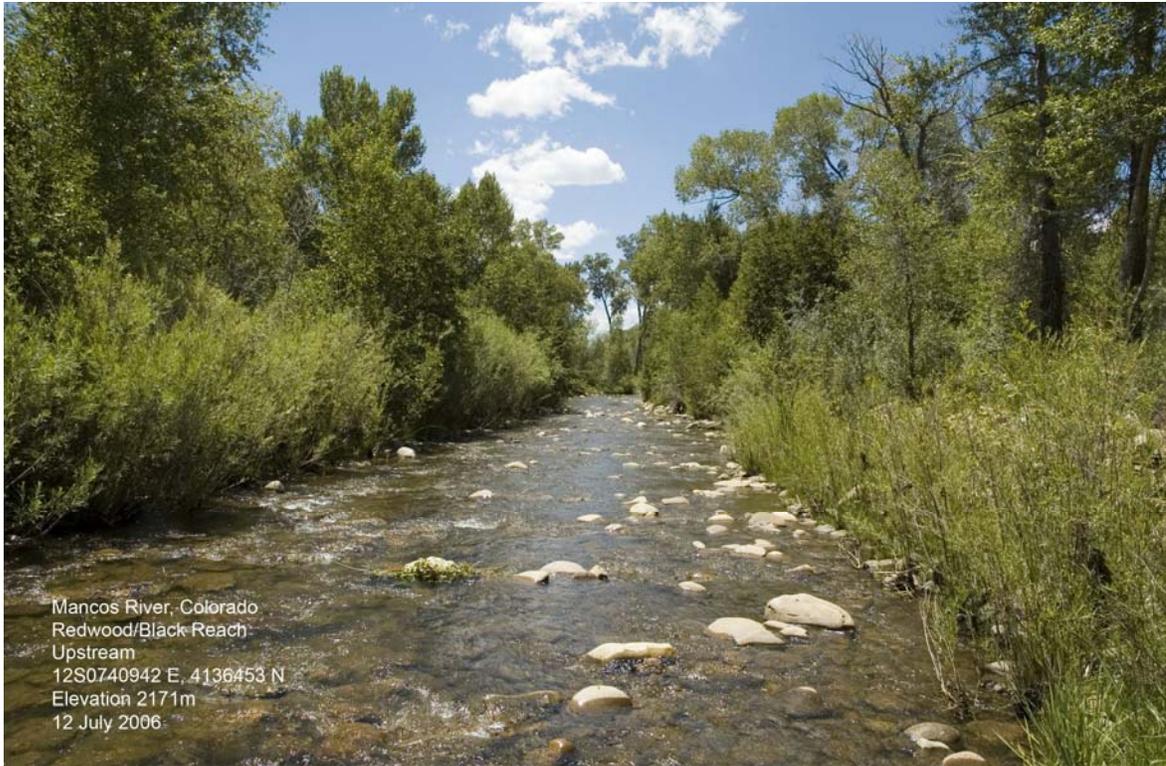
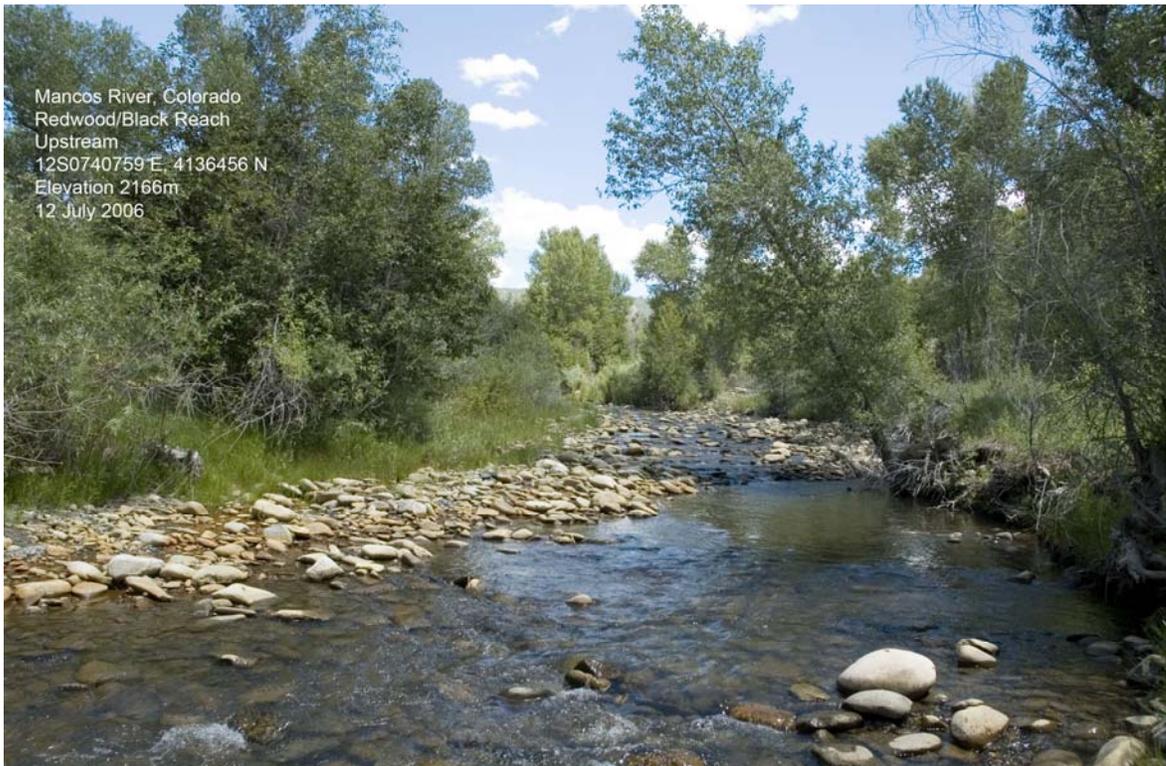
Figure 19. Reference Photos for the Redwood/Black Reach, Mancos River.

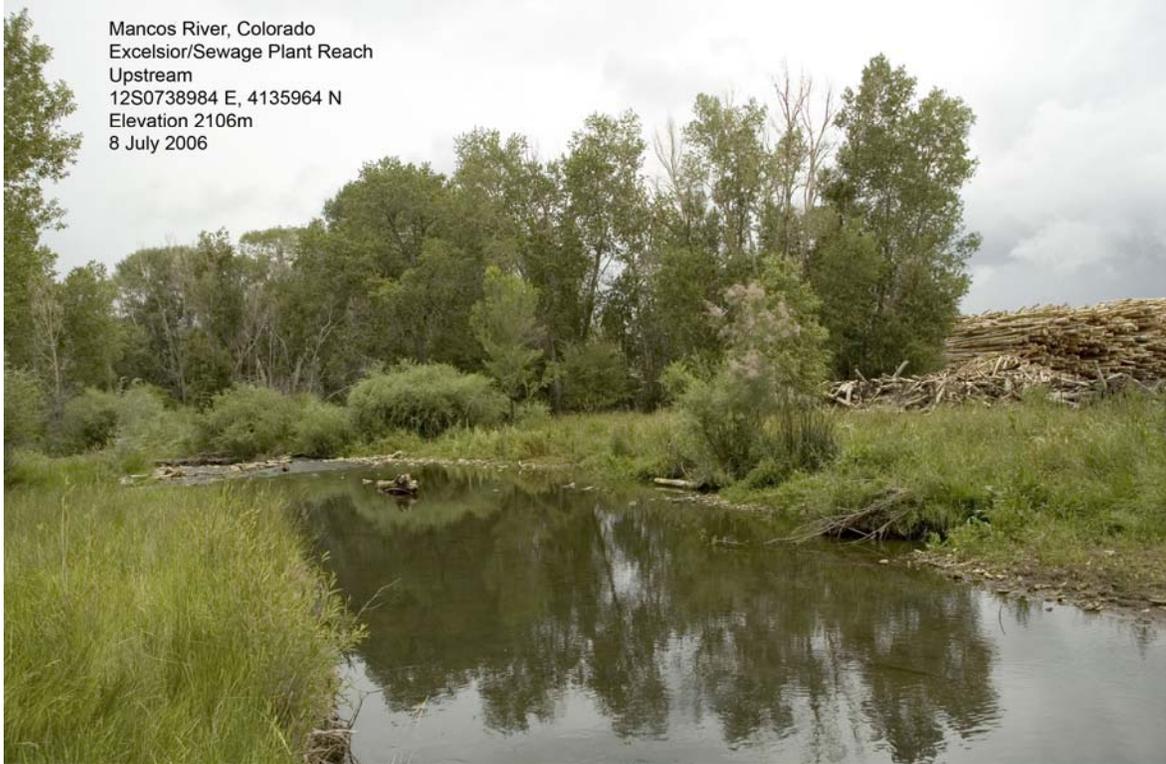
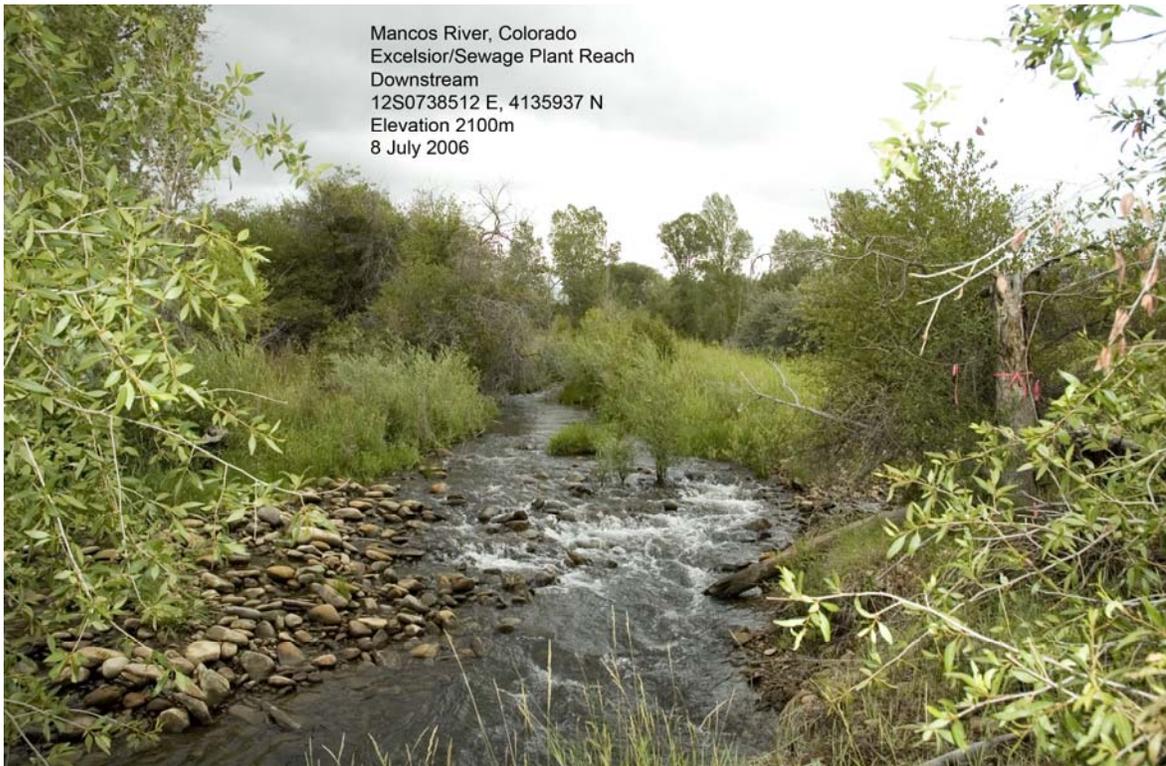
Figure 21. Reference Photos for the Excelsior/Sewage Plant Reach, Mancos River.

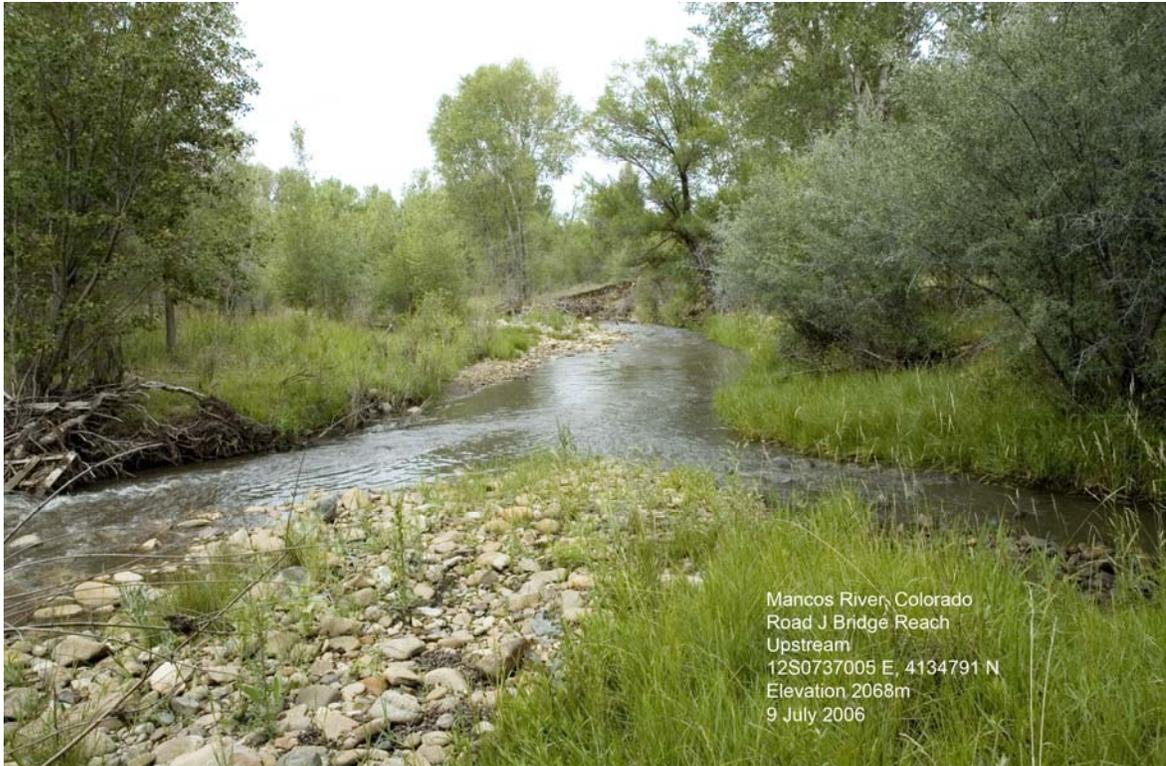
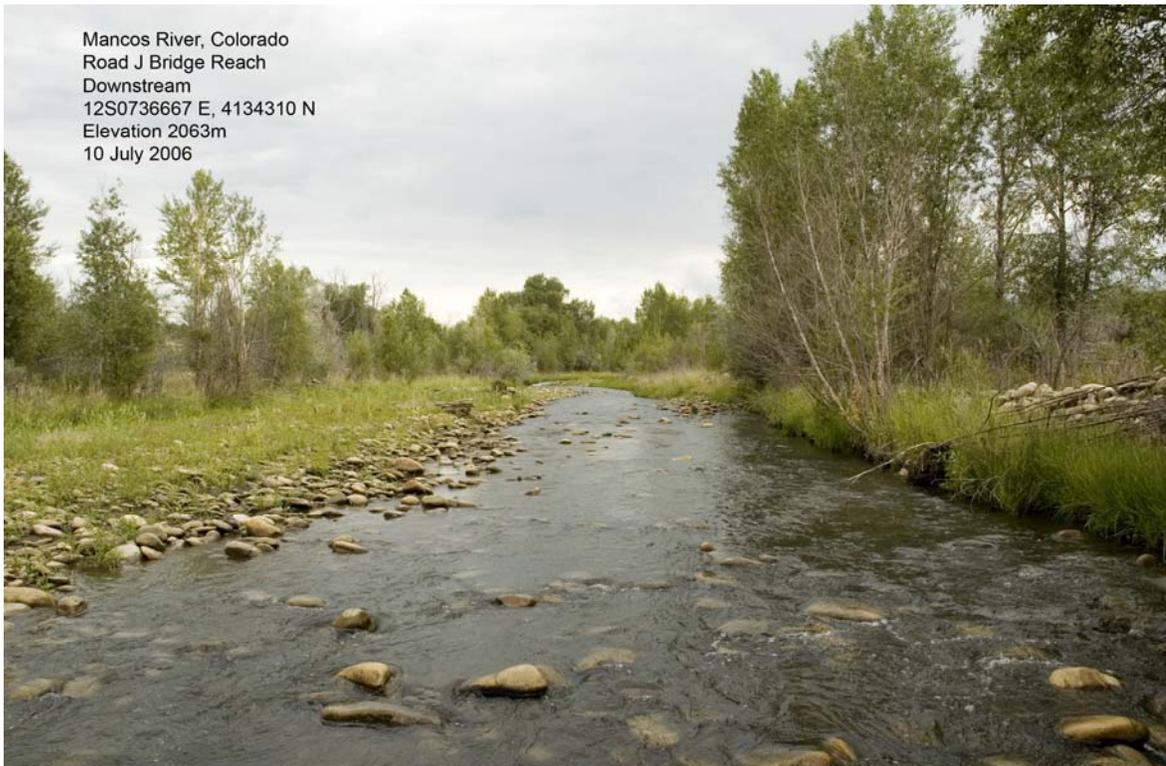
This reach is located just upstream from the Road J Bridge, and begins just below the confluence of Chicken Creek and the Mancos River. Chicken Creek at this point is highly modified and resembles an irrigation ditch. The channel of the Mancos River in this reach is wide and shallow, like many other reaches in the valley. Old cobble levees, one to two meters high, line the channel banks for most of the length of the reach. There are pastures in the historic floodplain on the south-eastern side of the reach, and mixed pastures and houses on the north-western side. The return of irrigation water has created side flows in the old floodplain, and the formation of wet meadows in some areas.

Algal growth was rated as good, but channel shading was only fair as a result of the lack of vegetation

Figure 23. Reference Photos for the Road J Bridge Reach, Mancos River.

along the cobble levees that line the channel. Water temperatures probably increase rapidly in this reach during sunny days.

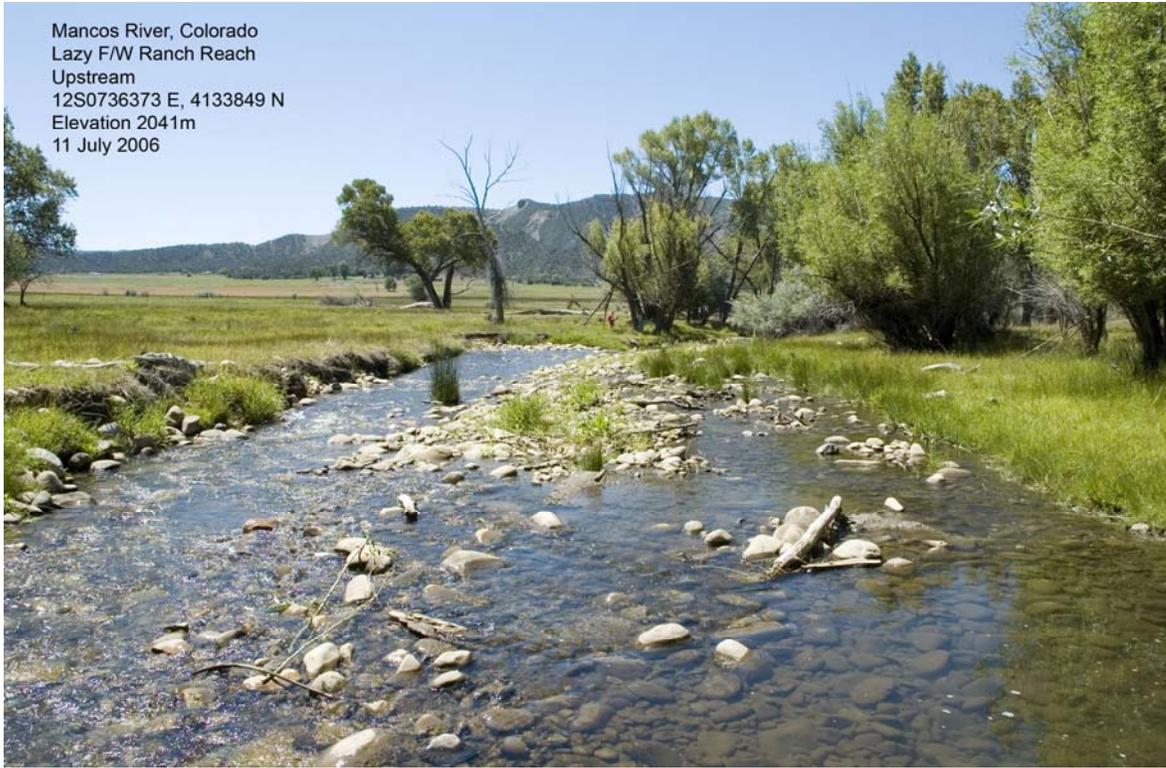
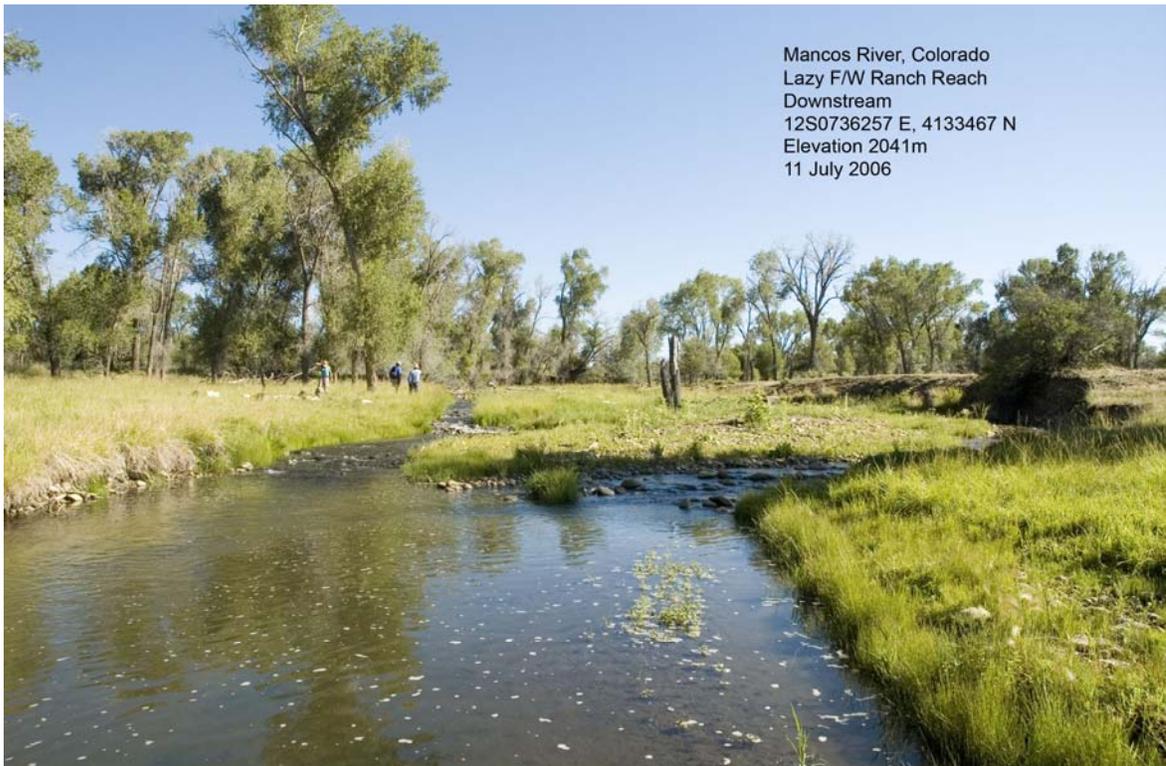
Figure 25. Reference Photos for the Lazy F/W Ranch Reach, Mancos River.

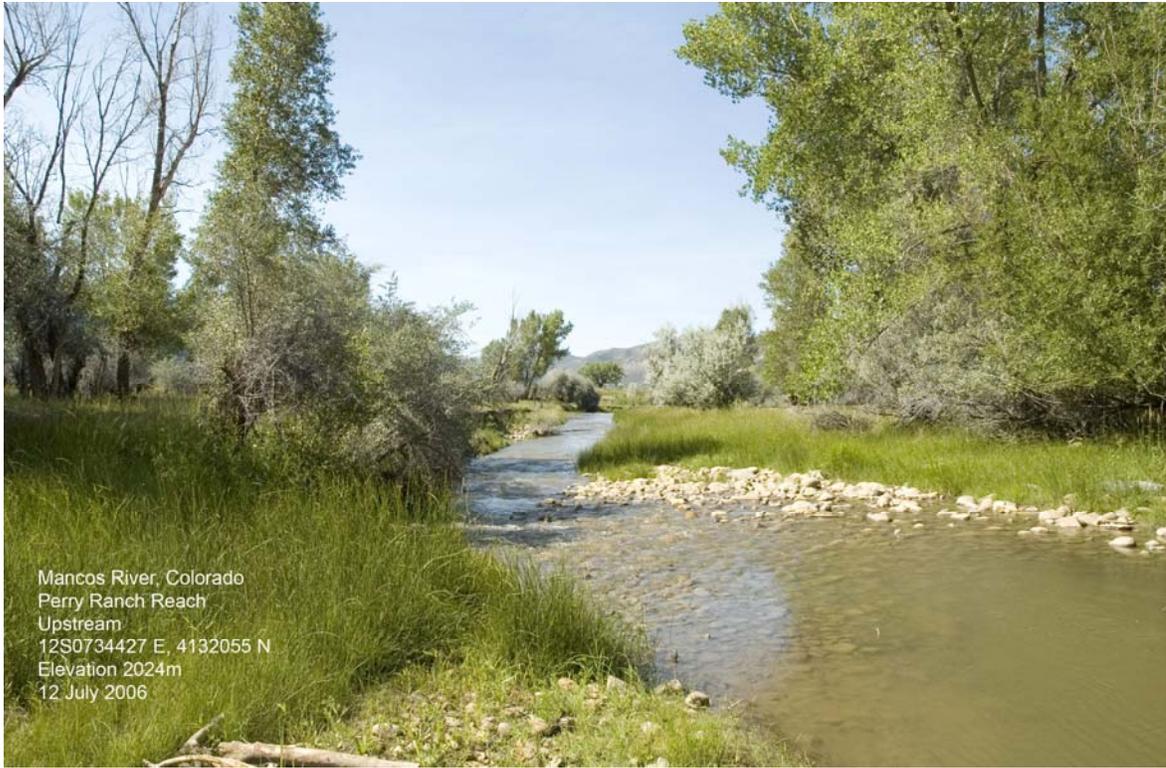
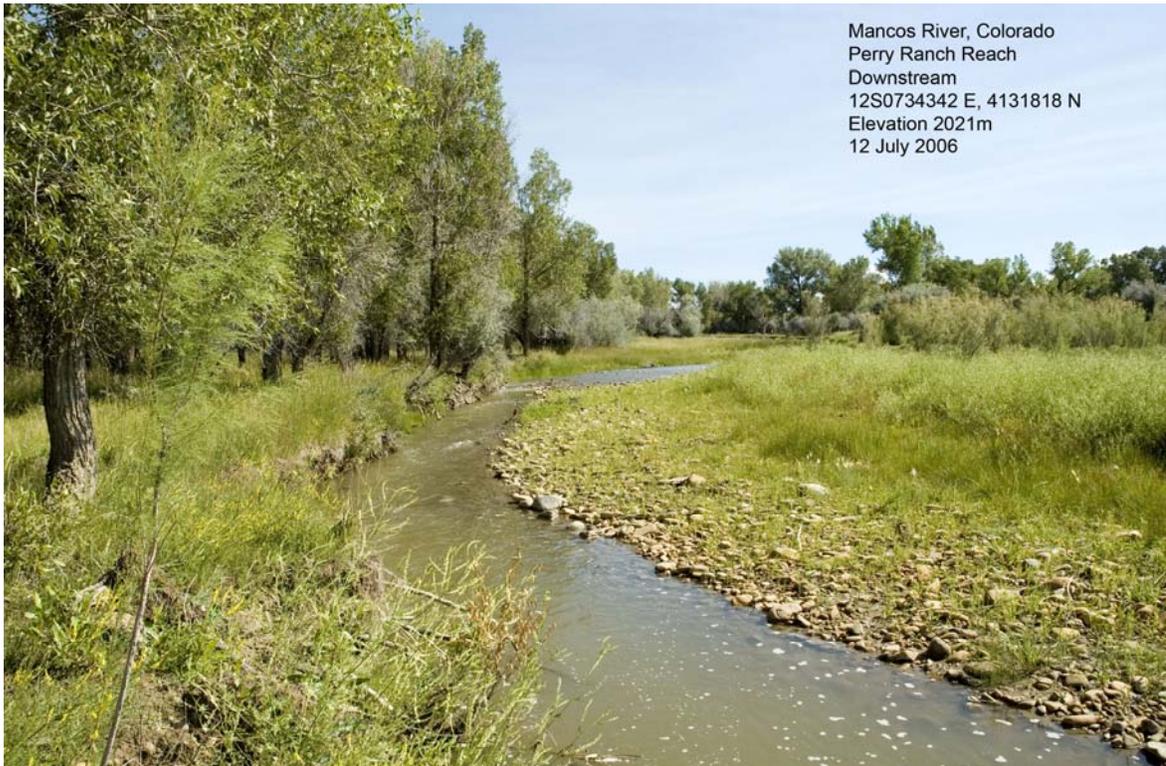
Figure 27. Reference Photos for the Perry Ranch Reach, Mancos River.

This reach is located on the Perry Ranch. The Mancos River at this point starts to turn north and south, before it enters Mancos Canyon. The ranch is an active livestock operation, and the floodplain on both sides of the stream had been grazed regularly in the years prior to the survey. The owners have discussed fencing off the riparian zone in the future. There are no levees in this reach. There is some return irrigation flow. On the west side, this has resulted in wet meadows at the base of the terrace forming the primary floodplain, and below the road. There are also wet areas on the east side, but these are generally above the historic floodplain.

Algal growth was poor, presumably as a result of nutrient input from livestock and possibly from

fertilizer. Solar shading was fair, as a result of only limited amounts of riparian vegetation along the stream banks.

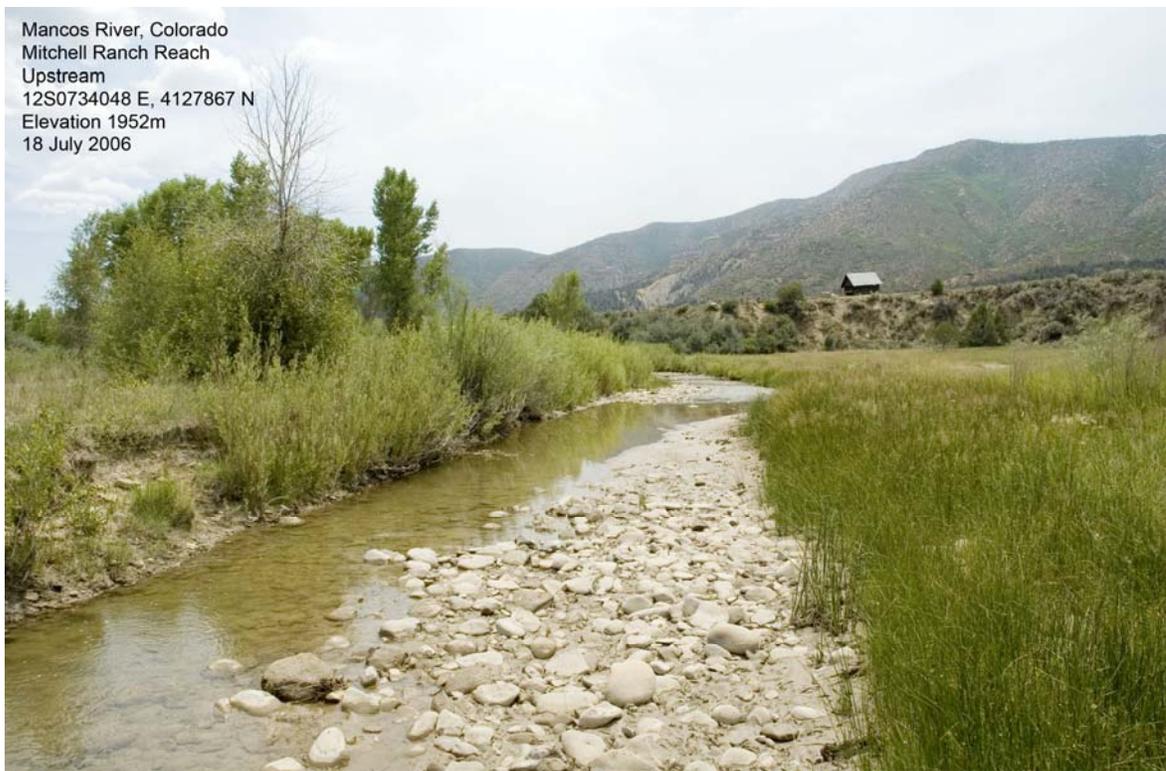
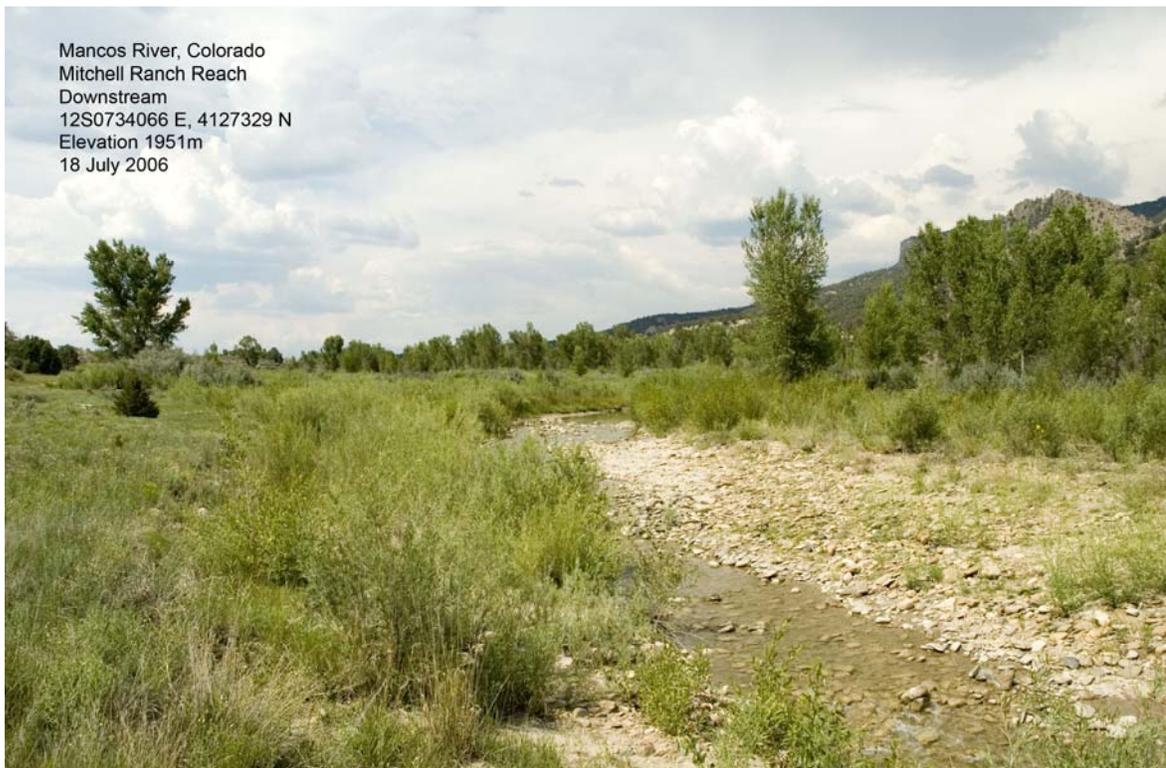
Figure 31. Reference Photos for the Mitchell Ranch Reach, Mancos River.

Hydrogeomorphology was variable. Vertical bank stability along the reach was excellent, indicating that the high levels of sedimentation (see below) were not originating locally. Riparian soil integrity was also excellent, possibly reflecting the current lack of use by livestock. However, floodplain connectivity and beaver activity were poor (the reach would be suitable for beavers when there are sufficient flows), and hydraulic habitat diversity was only fair. There was little active channel migration as was observed upstream on the Soussanna Ranch reach.

Fish and aquatic habitat ranged from good to poor. Pool distribution and overbank cover was good, but underbank cover was limited (fair) and there was no woody debris (poor). Cobble embeddedness was high (46% or a score of fair), and similar to the most downstream sample value in the Soussanna Ranch Reach that is upstream from this location. No aquatic macroinvertebrate insects were observed. There were a few crawfish at the sample sites, and several small unidentified fish were observed elsewhere along the reach.

The riparian vegetation appears to be recovering after a history of heavy grazing. Lower and upper riparian zone vegetation coverage averaged a rating of good, but this was due exclusively to grass/forb and shrub coverage. There was no cover from middle or upper canopy trees in the sample transects. Shrub and tree demography was very good; seedlings were present for both categories, and the only age classes missing were old clumps or snags in both cases. Non-native grass and forb cover was very high (estimated at 70% of total coverage, a rating of poor), but there were very few non-native shrubs and trees. The latter situation is very atypical of similar reaches in the American southwest, where saltcedar and Russian olives are normally very common along streams that have had a long history of grazing as well as the other characteristics of this reach. The levels of current grazing and browsing both received excellent scores, reflecting a lack of use of the riparian zone at the present time by both domestic livestock and native ungulates in this reach.

Terrestrial wildlife habitat was variable, ranging from fair (middle canopy trees) to very good (shrub patches). Fluvial habitat diversity was poor, which probably reflects a lack of channel migration along this reach in the past. However, if current conditions continue, this important fluvial process is likely to reestablish itself within the reach.

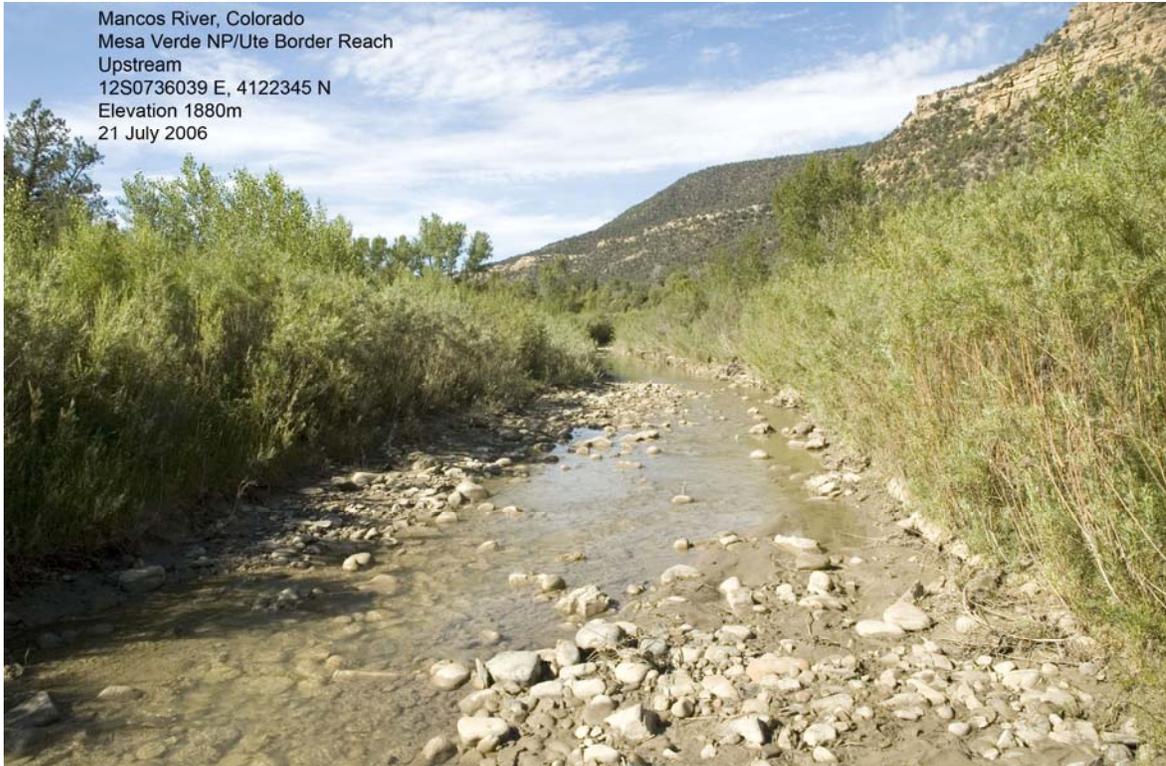
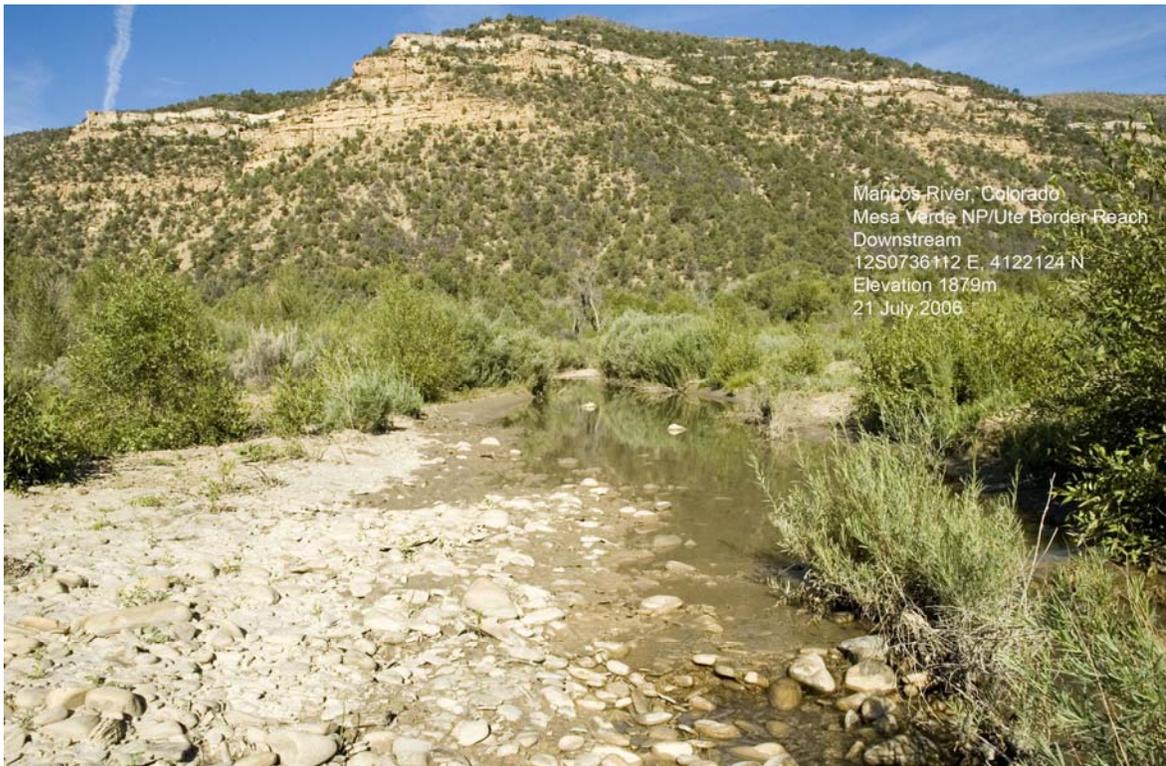
Figure 33. Reference Photos for the Mesa Verde NP/Ute Mountain Ute Indian Reservation Border Reach, Mancos River.

This reach is located within Mancos Canyon, on Mesa Verde National Park lands just upstream from the mouth of Weber Canyon. Weber Canyon is a major drainage that enters the river from the east, and it contains a number of ranches and irrigated pastures. At the time of the assessment, there was little water entering the Mancos River from Weber Canyon. The river here is very low gradient relative to reaches upstream (estimated at 1 meter drop over 200 meter channel length). The width of the flood plain in this section of the canyon is variable; at the assessment reach it was at least 100 meters wide. The stream itself is wide and shallow. There are no levees

and the channel is actively migrating. There are the expected numbers of meanders and point bars. There is considerable sediment in the stream, and many of the cobbles are embedded in a matrix that is dark and presumably contains charcoal from the recent wildfires in Mesa Verde National Park. This matrix was very cohesive, and formed a type of “pavement” along the bottom of parts of the channel. This may have a long-term impact on the health and recovery of the stream. Personnel from the Park indicated that an active program to remove exotic shrubs and trees had recently been completed along this reach. This effort has been successful, as only one individual saltcedar was observed in the survey area. This section of the canyon historically has been used by domestic livestock, but the Park does not allow grazing at the present time. However, there were numerous signs of trespass grazing in the reach at the time of the assessment.

Fish aquatic habitat ranged from poor to excellent. Pool distribution and overbank cover were both excellent (the latter score was the result of dense patches of willows that lined the bank of most of this reach). Cobble embeddedness was poor (68%) and no macroinvertebrate insects were found in the reach. A number of crawfish, and a few small unidentified fish, were observed in the stream. There was no large woody debris— the reason for the absence of this material was not clear given the forested slopes of the canyon and the presence of some large cottonwoods in the flood plain. Underbank cover was rated as fair.
