FUNCTIONAL ASSESSMENT OF THE MANCOS RIVER WATERSHED:

MANCOS VALLEY AND ADJACENT AREAS

PETER STACEY
UNIVERSITY OF NEW MEXICO

Prepared Under Contract with the
Mancos Conservation District
Mancos, Colorado
April, 2007

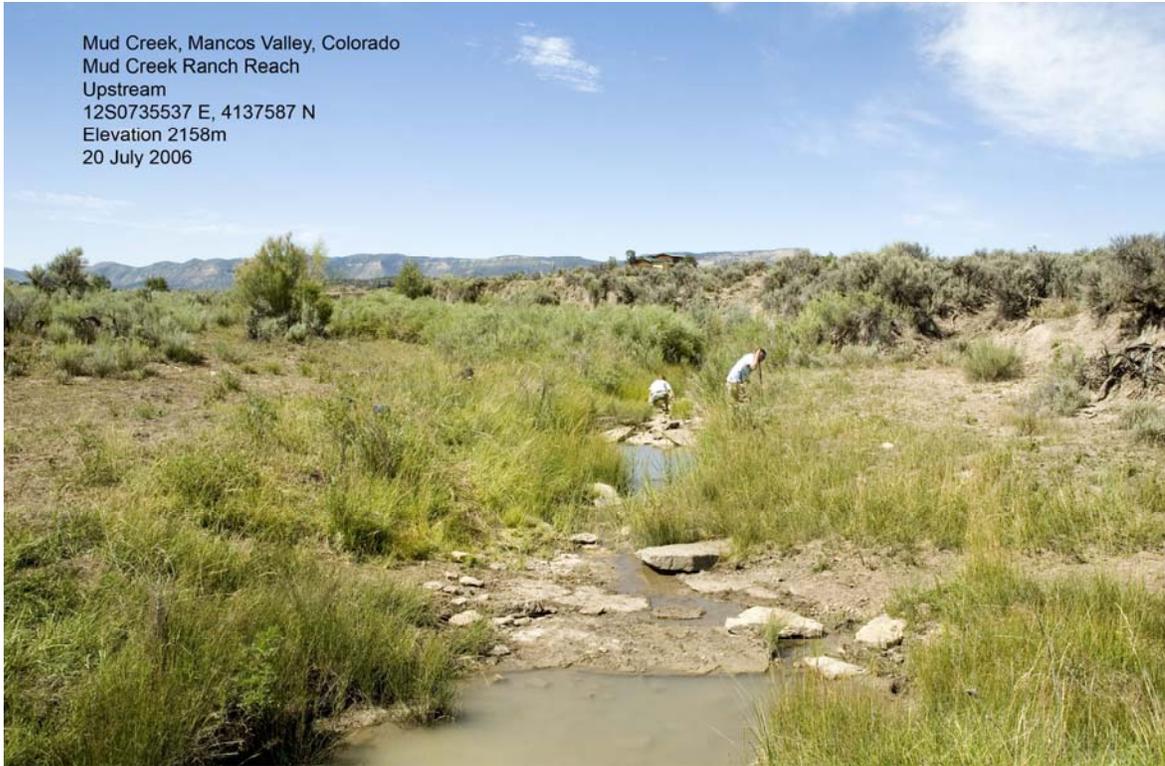
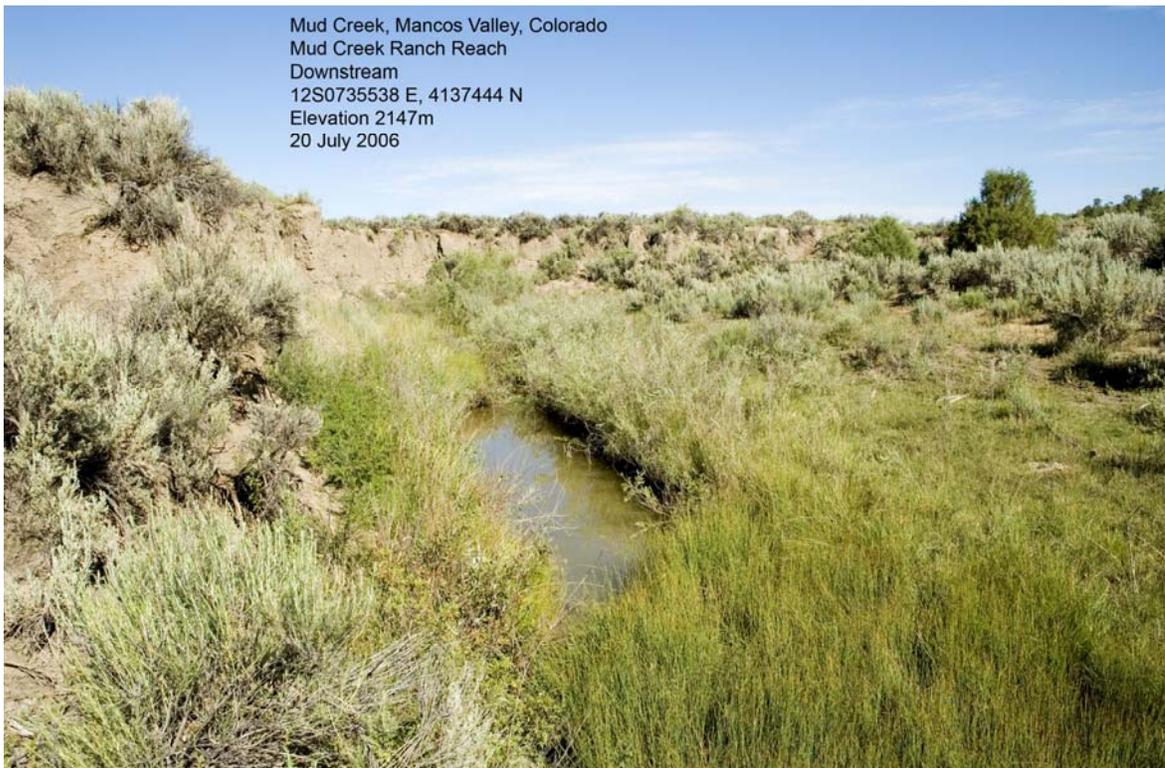
Figure 37. Reference Photos for the Mud Creek Ranch Reach, Mud Creek.

Riparian vegetation was also variable. There was good grass/forb and shrub cover in both the lower and upper riparian zones, but less than 3% cover in either zone for middle canopy trees, and no cover at all for upper canopy trees (no large cottonwoods were observed, although there were a few mature individuals just upstream from the assessment reach). Most of the shrub cover was from sagebrush, with only limited willows present. Overall, cover was good for the lower riparian zone, and only fair for the upper riparian zone. Shrub demography was very good, but tree demography was only fair (only a single age class present). Non-native grasses and forbs were assessed as poor (>50% of the cover was non-native), but non-native shrub and tree cover was very good, with only a few saltcedar individuals present within the reach. Grazing impacts were good, possible because there was limited food for livestock along the reach. Browsing was also good. Native ungulate use of the reach may be limited by the lack of suitable bedding and hiding cover near the stream.

In contrast, the reach on Mud Creek received the lowest overall score of any of the areas examined in this study, and was rated at 2.2, or in just fair condition. The creek and the surrounding areas have been used for livestock grazing for many years, and this has impacted the amount of vegetation cover that is now present in the riparian zone of Mud Creek. There historically may also have originally been some irrigated agriculture along parts of the creek, but at a much smaller scale than in Mancos Valley itself. There was a sprinkler irrigated field on the east side of the creek above the current flood plain, but runoff from this field appeared to have minimal, if any, impact on the riparian zone itself. The watershed that is drained by Mud Creek is relatively small, and is lower in elevation than those of the other major tributaries in the upper Mancos Watershed. As a result, Mud Creek receives less runoff from snow melt, and normal water flows tend to be lower here than in the other tributaries. Mud Creek, does, however, flood during periods of heavy summer rains. We found that there has been extensive downcutting of the channel in Mud Creek, which now rests on Mancos Shale bedrock in portions of the survey reach and elsewhere, as illustrated in the photograph in Figure 37A. Because the Mancos Shale formation contains considerable salt, there has been concern that the exposure of the shale and the erosion of surrounding fine alluvial soils in Mud Creek may be contributing inordinately to the salinity problem in the Mancos

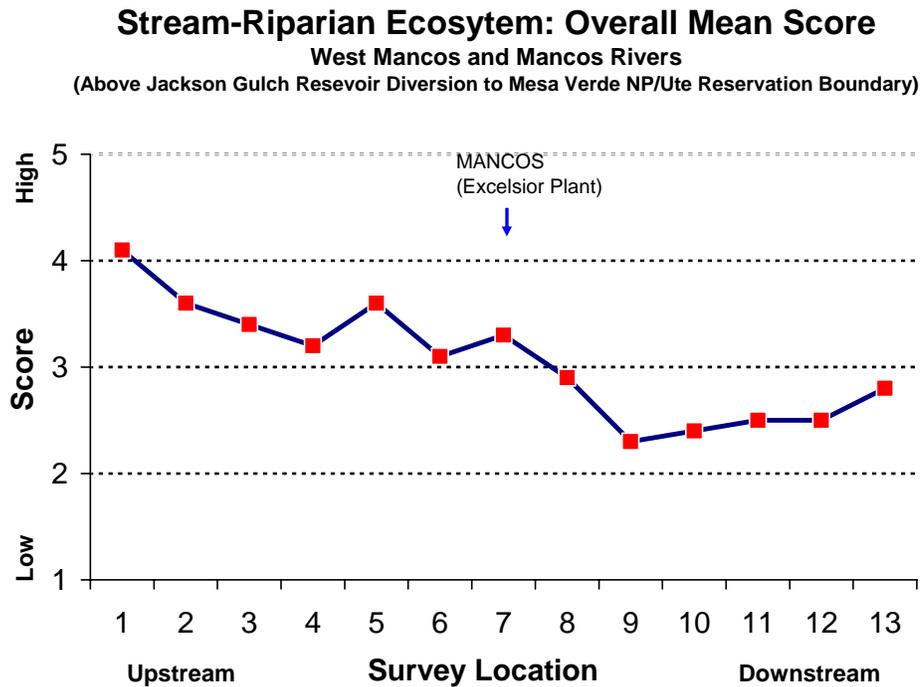
Figure 39. Overall mean score for the functional condition of the survey reaches in the Mancos Valley and adjacent upstream and downstream areas (see text).

Figure 39 plots the overall condition score for the reaches included in the trend analysis. As might be expected, the condition of the stream-riparian ecosystem declines as one moves downstream through the Valley. It begins to improve once again after the river enters Mancos Canyon, although the data from the canyon itself are limited to the single site at the confluence of the river with Weber Canyon.

All of the reaches that were surveyed have been impacted to some extent by human activities. The trend in Figure 39 suggests that not only are these impacts most intense at the lower part of the Valley, but that some of these impacts (such as water diversions) may also have a cumulative effect on the river ecosystem. Since the overall mean score is simply a composite of individual scores, any interpretation of this pattern must consider all of the variables included in the RSRA survey. These are presented below.

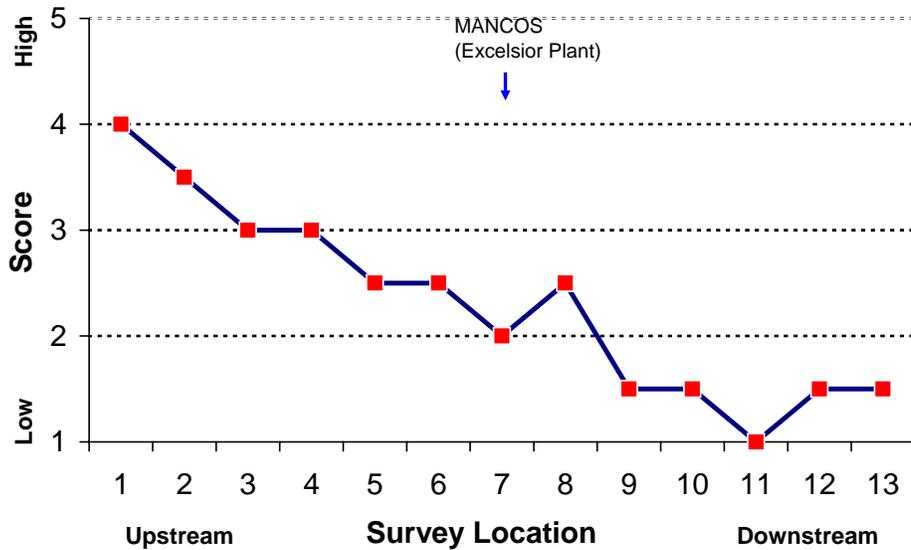
Figure 40. Mean scores for non-chemical Water Quality for reaches in the Mancos Valley and adjacent upstream and downstream areas (see text).

Figure 40 gives the mean non-chemical water quality scores for the reaches in this analysis. The scores are high before the river enters the Valley and then decline significantly by the time the river enters Mancos Canyon at the bottom end of the Valley.

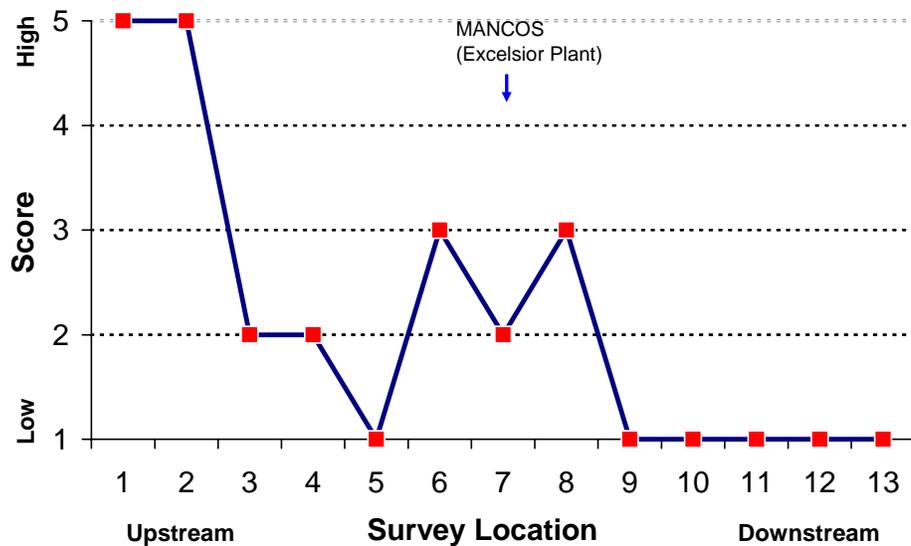
Figure 41. Scores for Algal Growth in reaches in the Mancos Valley and adjacent upstream and downstream areas (see text).

The RSRA protocol examines two aspects of water quality. The first, the amount of filamentous algal growth within the channel, reflects the amount of nutrients in the stream, such as nitrogen and phosphorus, as well as other types of pollution like animal wastes. Some amount of algae is natural in streams and rivers, and in fact is an important part of primary production within the aquatic system. However, excessive amounts of algae are usually harmful, since it will eventually cause oxygen depletion in the water column when the dead algal cells are decomposed by bacteria. This in turn will impact both aquatic insects and fish (adults and eggs). The scores for Algal Growth are shown in Figure 41. The two reaches upstream of the Valley, which are located in areas with limited human and agricultural impacts, score excellent. However, the amount of algal growth increases greatly as the river moves through the valley, to the point where algal growth may be of concern during certain periods of the year (for example, during low flows and when stream temperatures are high). The fact that there is less algal growth in the reaches that are in or directly adjacent to the town of Mancos suggests that the nutrients leading to the excessive growth are related to runoff from pastures and fields, rather than coming from urban input (including any impacts of the sewage plant). As noted below (Figure 53), the observed high levels of algae cover did not lead to an absence of macroinvertebrate diversity in the middle and upper part of Mancos Valley, suggesting that it was not a major problem in those areas at least during the survey period. There were, however, very few aquatic macroinvertebrates found in the reaches in the lower part of the Valley. This suggests that the accumulating nutrient loads, when combined with limited water flows present in the lower valley, may be an issue in those areas.

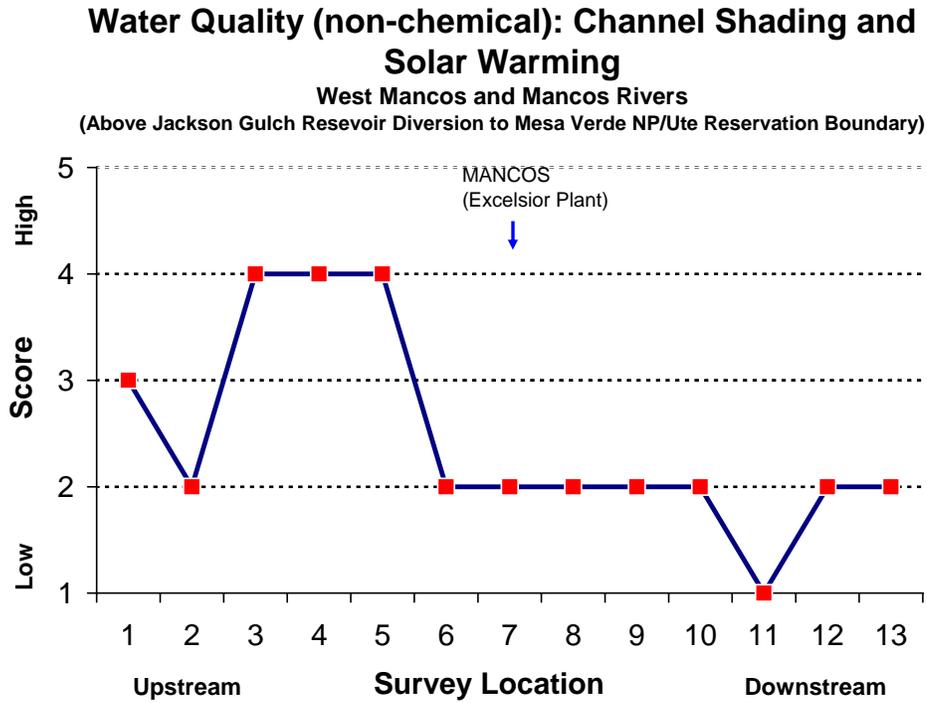
Figure 42. Scores for Channel Shading in reaches in the Mancos Valley and adjacent upstream and downstream areas (see text).

As shown in Figure 42, the amount of channel shading was variable. It was poorer than expected in the upstream reaches on the West Mancos. This was due to the fact that the channel in these reaches was wide and shallow, as a result of past ditch and diversion structure construction activities. The scores were higher for the reaches in the upper part of the valley, where there was well developed stream-side vegetation. But in the lower part of the Valley, shading was low, due to both channel morphology (wide and shallow) and the lack of overhanging vegetation. The high scores in the upper valley suggest that the river could be well shaded through all of its length in the Valley and Mancos Canyon with appropriate management and restoration of the taller vegetation.

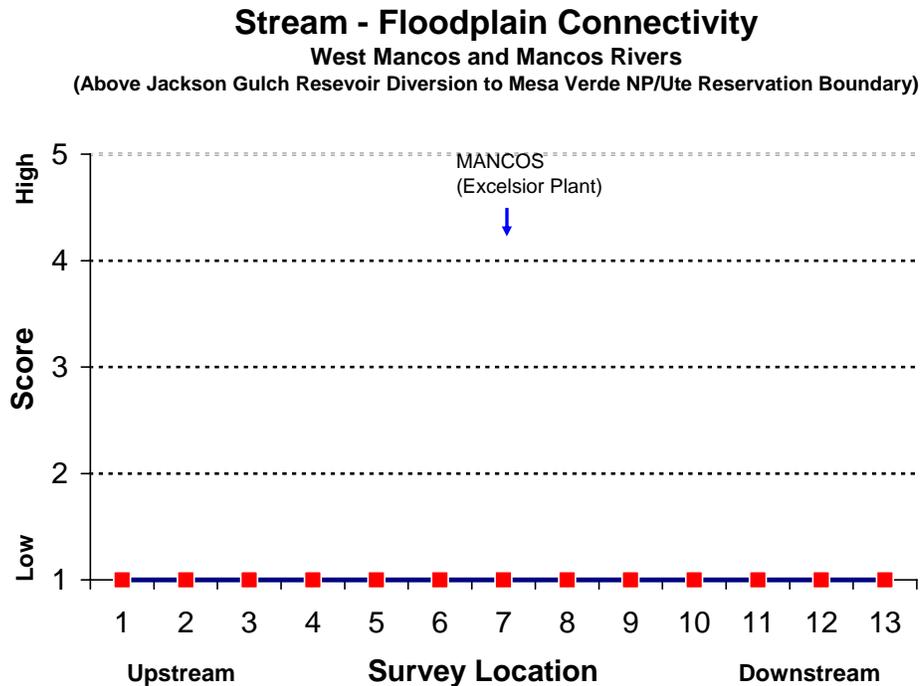
Figure 44. Scores for Stream-Floodplain Connectivity in reaches in the Mancos Valley and adjacent upstream and downstream areas (see text).

riparian zone. Flooding helps to maintain a high water table and moist soils, it adds nutrients to riparian soils, and it can encourage the germination and productivity of riparian plants. Conversely, when a stream or river is either downcut in a deeply incised channel, or it is isolated from the adjacent flood plain by artificial structures like levees, periodic flooding becomes impossible. Lack of flooding tends to dry out the riparian zone, to prevent the germination of new native plants, and encourage the invasion of upland and non-native plants like many exotic weeds and saltcedar. As shown in Figure 44, the survey reaches received uniformly low scores for flood plain connectivity. This was the result of both intentional levee construction, and in a few cases, an unintentional consequence of other construction activities (e.g., the Mesa Verde Pipeline in the Below Jackson Gulch Diversion reach). A consequence of

this situation is that the historic flood plain of the Mancos River in most of the Mancos Valley and the adjacent areas is no longer flooded by the river except during extreme run-off events. The implications of this situation are discussed in detail below.

As shown in Figure 44, above, the flood plain in the survey area is almost completely disconnected from the active stream channel: all reaches received the lowest possible score of 1. As a result, the flood plain of the Mancos River in this area probably rarely receives any overbank flooding, except during periods of extremely high flows. There was little evidence that this type of flooding had occurred recently in any of the reaches examined. In most stream and river systems in the American Southwest, where the channel is as isolated as it is from its flood plain as it is in the Mancos Valley, the flood plain typically would have dried up, and there would normally be very little riparian vegetation present in the URZ. In spite of the lack of channel connectivity and overbank flooding, the riparian vegetation in most of the study reaches within the Mancos Valley itself is currently very healthy. Grass cover is extensive (Figure 63), and there are numerous wet meadows and even some cat-tail marshes throughout the entire riparian zone. The shrubs and trees that are present are healthy, and there are numerous seedlings of both willows and cottonwoods in the flood plain (see Figures 66 and 67 below). Both of these plants require moist soil conditions to germinate and grow. Because the amount and the condition of the riparian vegetation currently found in the flood plain is not consistent with the channel geomorphology of the Mancos River in this area, and the apparent lack of frequent overbank flooding due to channel incision and the presence of levees in many reaches, there must be some other input of surface and underground water flow into the flood plain. This flow must be from sources adjacent to, but outside the floodplain.

We found that the flood plain of the Mancos River within Mancos Valley is in very good condition, even though the river channel is actually isolated from it adjacent flood plain throughout most of the valley (Figure 44, above). Although there is little active downcutting or erosion of the stream banks at the present time, the river in most reaches is wide and shallow, and the bottom and the sides of the channel are lined with medium to large cobbles. The wide and shallow channel shape, which would usually be indicative of poor conditions, is due in the Mancos Valley primarily to the presence of levees along the river, particularly both immediately upstream and downstream from the town of Mancos itself. However, constructed levees are generally absent from some of the reaches in the lower part of the Valley, and in those areas the river is starting to exhibit the type of meandering pattern that would be expected to occur naturally.

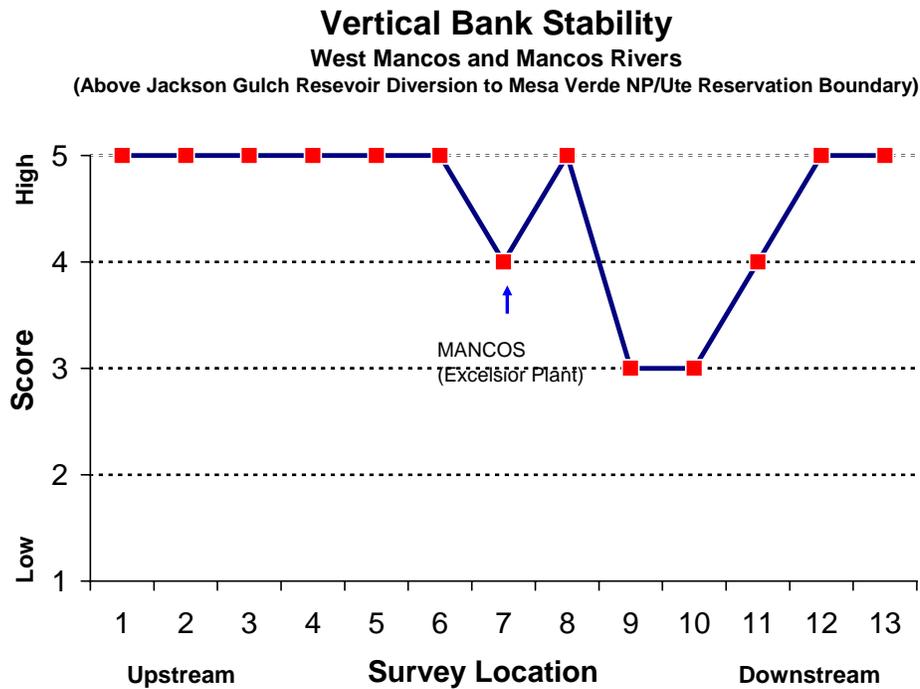
Figure 45. Scores for Vertical Bank Stability for reaches in the Mancos Valley and adjacent upstream and downstream areas (see text).

Scores for Vertical Bank Stability were generally very good. This resulted from a combination of the presence of levees on the banks in many upstream areas, along with well developed vegetation elsewhere. The areas where the scores were lower tended to be located in the reaches where there was

substantial livestock use; however the situation in these reaches did not appear to be problematic because the channel was undergoing normal migration where the banks were unstable. Overall, the high scores for vertical bank stability are one reason why there is little active erosion or heavy sediment loads in this part of the Mancos River.

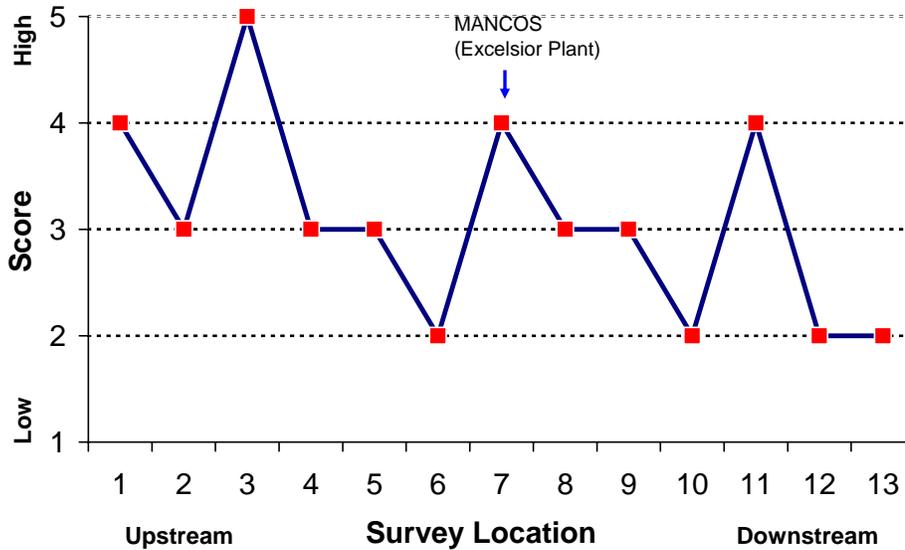
Figure 46. Scores for Hydraulic Habitat Diversity for reaches in the Mancos Valley and adjacent upstream and downstream areas (see text).

The scores for Hydraulic Habitat Diversity for the survey reaches are given in Figure 46. Different types of hydraulic features result from the interaction of the moving water column and the underlying physical substrate(s), and they provide habitats for different species of aquatic life as well as for different life-history stages of the same species. Highly modified or disturbed stream systems are often structurally simple: the channels are often straight and narrow, with a uniform depth and bottom). As a result, these streams and rivers often lack the diversity of hydraulic habitats necessary to support a diverse complement of aquatic species. The scores for the Mancos River in the survey area were variable, but they generally declined as one moves further downstream. In many cases, the combination of leveed banks, a cobbled bottom, and the absence of woody debris (which can create local erosion and increased structural diversity) where responsible for the lower scores. However, the fact that several of the downstream reaches did have very good scores for this variable indicates that there is the potential to increase hydraulic habitat diversity throughout the Valley in the future.

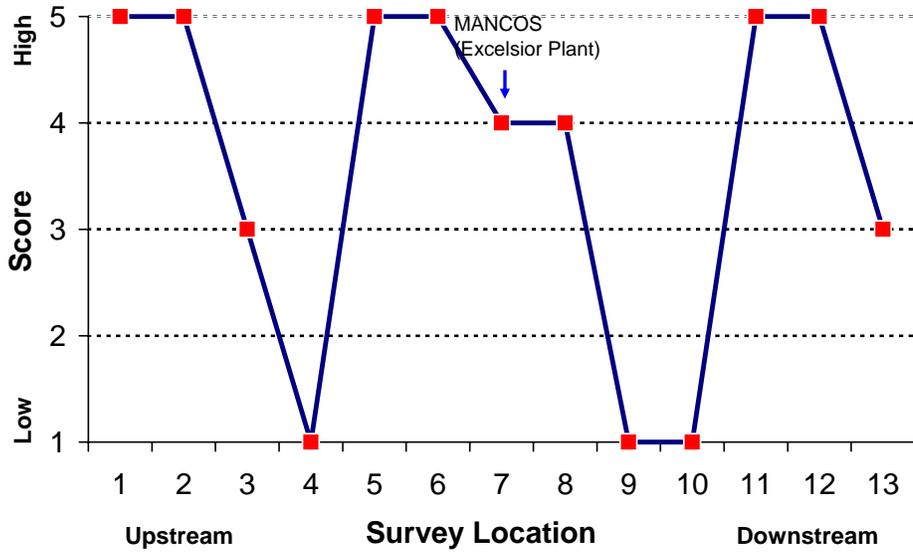
Figure 47. Scores for Riparian Area Soil Integrity and Disturbance for reaches in the Mancos Valley and adjacent upstream and downstream areas (see text).

well as to the invasion of the flood plain by upland and non-native or exotic species. The degree of soil disturbance was highly variable in the survey area, and showed no clear pattern as one moves downstream. There was little disturbance in reaches above the valley and in the areas near the town of Mancos. The lowest scores occurred in agricultural reaches where there was active use of the floodplain by domestic animals; however there were adjacent areas that were also used for livestock operations that received very high scores. This suggests that the degree of riparian area soil disturbance within a reach tends to reflect the specific management practices that are in place on that particular reach.

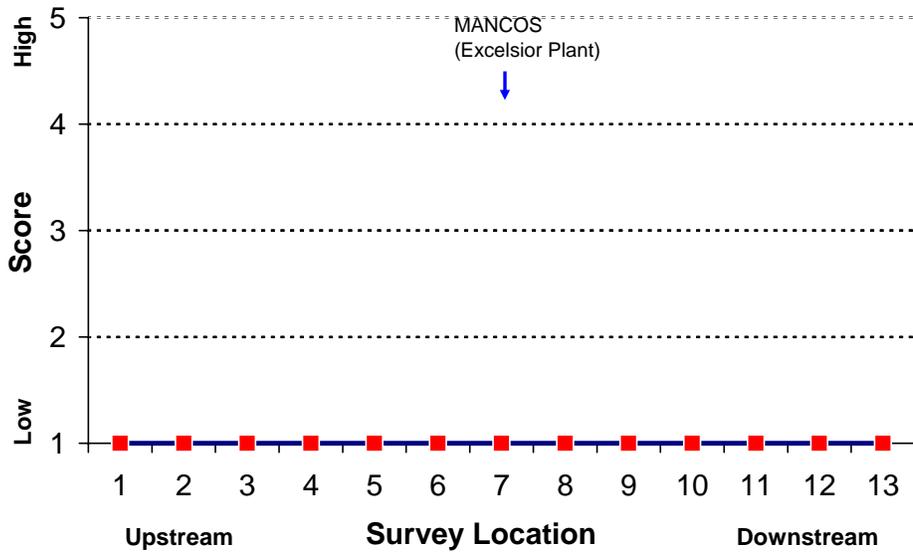
Figure 48. Scores for Beaver Activity for reaches in the Mancos Valley and adjacent upstream and downstream areas (see text).

The final variable in the hydrogeomorphology sections is for beaver activity (Figure 48). Beavers are keystone species in most stream-riparian ecosystems, and they once occurred in almost all of the small and medium-sized streams and rivers in the western United States. Beavers alter many hydrogeomorphological and ecological processes: their dams and the ponds behind them reduce flooding and the annual variation in water flows, they collect silt and they reduce erosion. Beaver ponds provide important habitat for fish, amphibians, and many other types of aquatic wildlife, and the marshes and wet areas on the edges of the ponds provide germination sites and adult habitat for many different species of riparian plants. We observed no beaver activity in any of the reaches for the trend analysis, although there were beavers present in Chicken Creek and adjacent to several of the other survey locations. Almost all of the reaches could support beavers, except perhaps those where woody riparian vegetation is limited at the current time. Their presence would have a major positive impact on the overall health of the stream-riparian ecosystem within in the survey area.

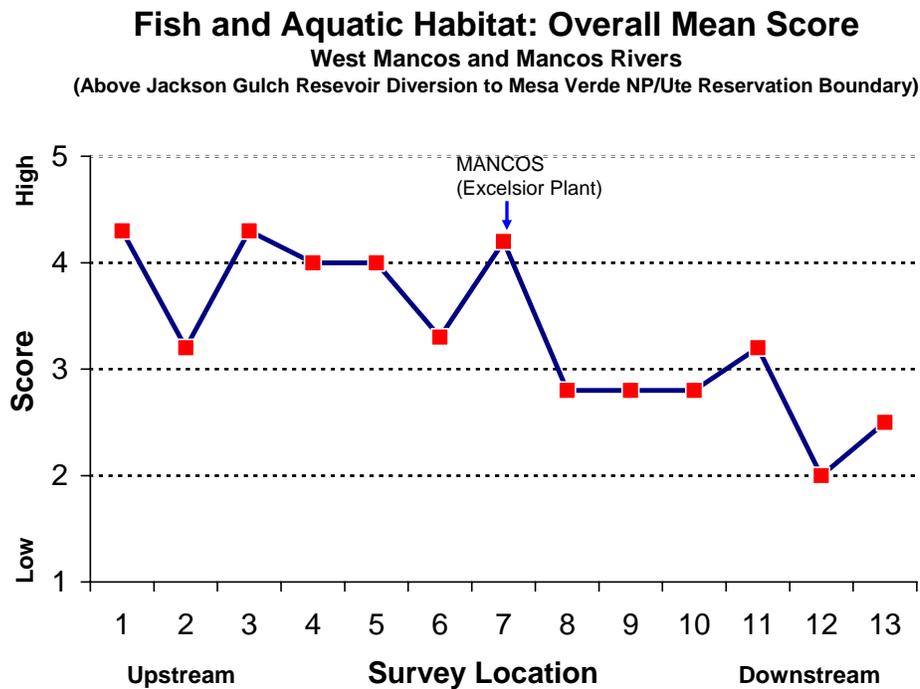
Figure 49. Mean scores for Fish and Aquatic Habitat for reaches in the Mancos Valley and adjacent upstream and downstream areas (see text).

As shown in Figure 49, the mean scores for fish and aquatic habitat were generally good in the reaches above the town of Mancos. Although there were a few problems in this area (see individual scores below), with minor restoration this part of the river would be likely to provide good habitat for native cold water fish species, including native trout. The condition of reaches in the lower part of the

valley below Mancos was not as good. Establishing native fish populations in this area would be more problematic, although still potentially possible. There was slight improvement of the fish and aquatic habitat in the last reach, the Mesa Verde/Ute Reservation reach in Mancos Canyon, although there were specific problems in that reach that made it currently unsuitable for many native species (see discussion above). It is possible that the reaches in Mancos Canyon were originally occupied by more warm water tolerant species than the upper reaches.

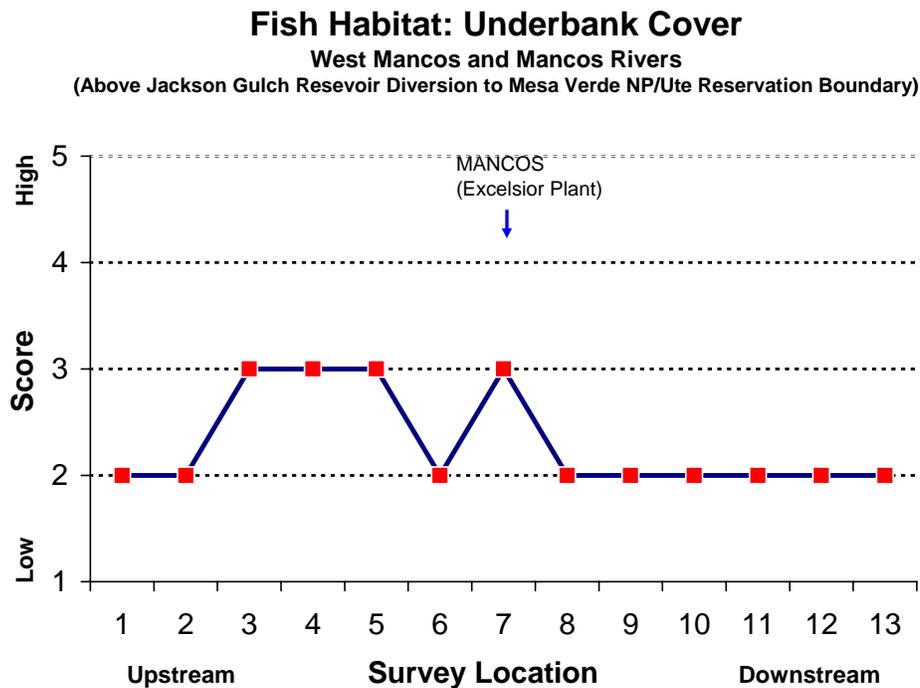
Figure 51. Scores for Underbank Cover for reaches in the Mancos Valley and adjacent upstream and downstream areas (see text).

There was only limited underbank cover for fish and other aquatic species throughout the Valley, as well as in the upstream reaches (Figure 51). This was primarily a result of levee construction (including in parts of the upstream reaches), although in a few areas downstream it was also the result of a wide and shallow channel morphology combined with only limited riparian vegetation along the banks.

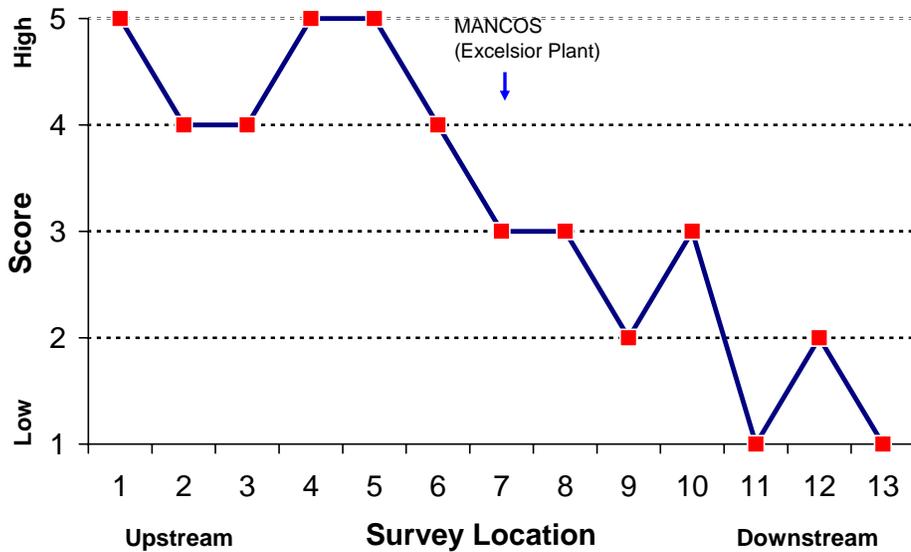
Figure 52. Scores for Cobble Embeddedness for reaches in the Mancos Valley and adjacent upstream and downstream areas (see text).

Figure 52 gives the scores for this variable. The level of cobble embeddedness was very good or excellent in the reaches above Mancos Valley, as well as at most of the above the town of Mancos itself. However, below the town, the degree to which silt and other sediments covered the cobbles increased, to the point where in the lower reaches the level of embeddedness was likely to limit both fish and aquatic insect production. This situation was probably the result of both reduced water flow (progressively more water is removed from the river for irrigation as one moves downstream, with the major removals occurring just above the town of Mancos), as well as increased sediment deposition into the channel due to lower levels of vegetation on the hillside surrounding the river in the lower parts of the valley. The cobbles in the lowest reach, at the Mesa Verde National Park- Ute Indian Reservation border, were almost fully covered by sediments and ash from runoff from the areas impacted by the recent fires on the west side of Mancos Canyon.

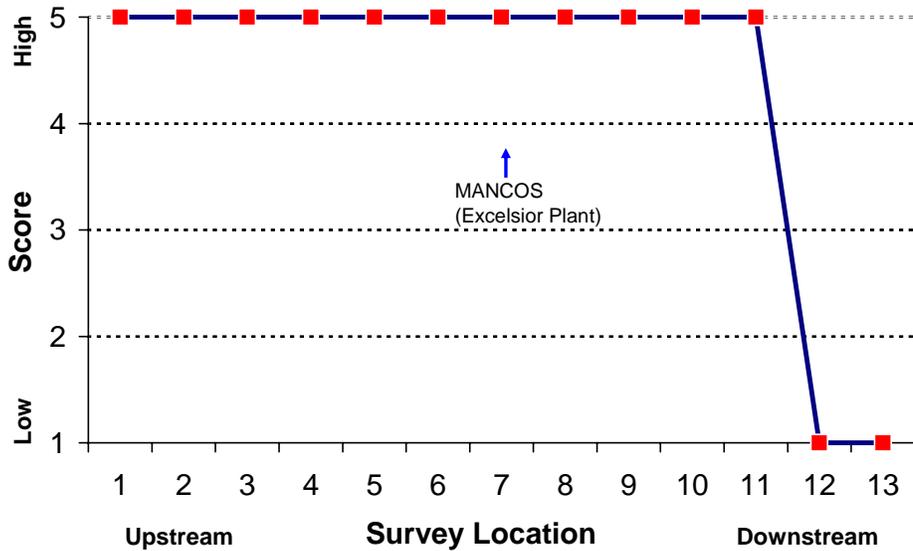
Figure 53 gives the scores for the diversity of aquatic macroinvertebrates themselves in the study reach. These species, which in this section of the Mancos River include primarily the aquatic larvae of insects such as caddis flies, mayflies, and stone flies, and similar species, not only provide food for fish, but their presence is a good indicator of stream health and water quality, including such factors as temperature stress, nutrient and pollutant loads, dissolved oxygen levels, and sediment loads (see above). Almost all of the reaches received excellent scores for this variable, indicating water quality is generally very good throughout the Valley, and that the town of Mancos is not having a major impact on water quality. The exception was the two most downstream reaches, where there were no aquatic insects whatever, and only a few crawfish were found. The absence of the insect macroinvertebrates appeared to be due to a combination in the lower reaches of low water flows (resulting in temperatures stress), possibly high nutrient loads (see Figures 41 and 42, above) and high levels of cobble embeddedness (Figure 52).

Figure 53. Scores for Aquatic Macroinvertebrate Diversity for reaches in the Mancos Valley and adjacent upstream and downstream areas. The two lower reaches held only crawfish (see text).

It should be noted that one of the other survey locations, not included in Figure 53, and on the East Mancos River near its confluence with the Middle Mancos, also had no aquatic invertebrates present during the surveys. This appears to be the result of some specific chemical pollution in the East Mancos upstream from the survey site, rather than the factors mentioned above for the downstream survey sites (see the individual description of the East Mancos reach, above).

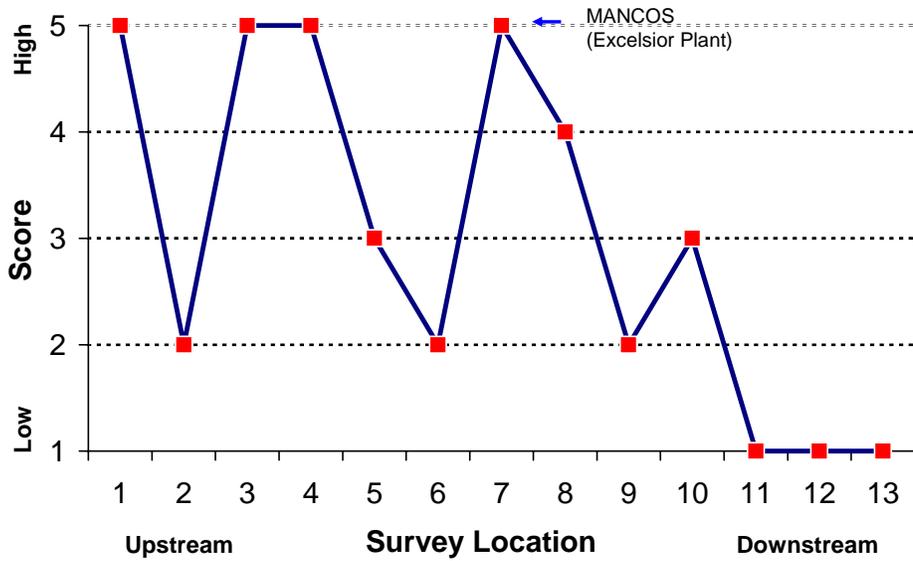
Figure 54 gives the scores for the amount of large woody debris that was found in the survey reach. LWD was defined as pieces of wood that were at least 15 cm (6”) in diameter and at least 1 m (3 ft) in length. Large woody debris that is resting in the stream channel or along the banks and at least partial submerged provides important fish and amphibian habitat, for nursery cover, feeding areas, and protection from predators. LWD also play an important role in shaping channel morphology and capturing silt, particularly in small and medium sized streams and rivers like the Mancos. Streams with adequate amounts of large woody debris tend to have greater habitat diversity, a natural number of meanders, and has greater resistance to negative impacts of high water flow. As seen in Figure 16, most of the reaches in the upper parts of the survey area had adequate or better amounts of LWD, although there were exceptions in the agricultural areas just above the town of Mancos. There was significantly less woody debris in the reaches in the lower parts of the valley; this probably was the result of both fewer trees along the banks that could fall into the river, as well of reduced water flows that would carry LWD that entered the channel in the upper parts of the area further downstream. As expected, much of the LWD in the reaches above the valley was pine and aspen trees, while downstream it consisted primarily of cottonwood. The latter decomposes quickly, and this factor may also contribute to the lack

Figure 54. Scores for Large Woody Debris for reaches in the Mancos Valley and adjacent upstream and downstream areas (see text).

of LWD in the lower reaches. The addition of LWD to the middle and lower reaches could result in a significant improvement in fish habitat and overall channel morphology.

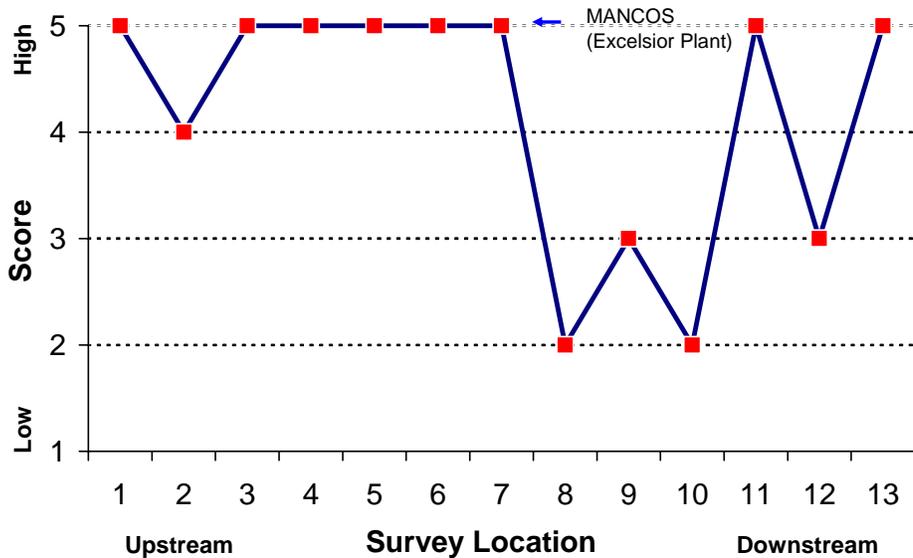
Figure 55. Scores for Overbank Cover and Terrestrial Invertebrate Habitat for reaches in the Mancos Valley and adjacent upstream and downstream areas (see text).

The final variable in the Fish and Aquatic Habitat sections examines the amount of terrestrial vegetation on the stream bank that actually overhangs the water, also is important for fish production and survival. Both the plant material itself and the insects that live on the vegetation can drop directly into the channel, providing a critically important source of food, energy and nutrient input into the stream for fish and other aquatic species. Overhanging vegetation also provides shading, and bank protection and sediment trapping during high flow events. As shown in Figure 55 above, the scores for overbank cover were generally excellent in the tributaries and upper parts of the valley. Below the town of Mancos, the scores fell to low levels in some reaches, where there was little vegetation at all along the stream banks. However, two of the three furthest downstream reaches again achieved excellent scores, indicating that this component of fish habitat quality could recover in the lower scoring areas with appropriate management.

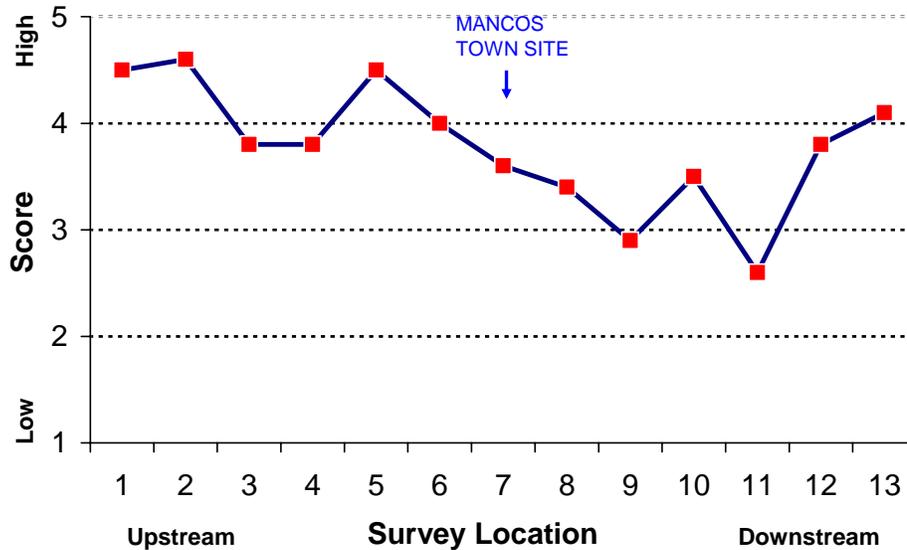
Figure 56. Mean scores for the Riparian Vegetation survey variables for reaches in the Mancos Valley and adjacent upstream and downstream areas (see text).

Figure 56 gives the mean scores for Riparian Vegetation in the survey area. The condition of the vegetation was generally very good in the survey reaches above the town of Mancos (including several agricultural areas), declined somewhat in the lower parts of Mancos Valley, and then began to improve again as the River left the valley and entered Mancos Canyon. The reasons for this trend are discussed in the following sections.

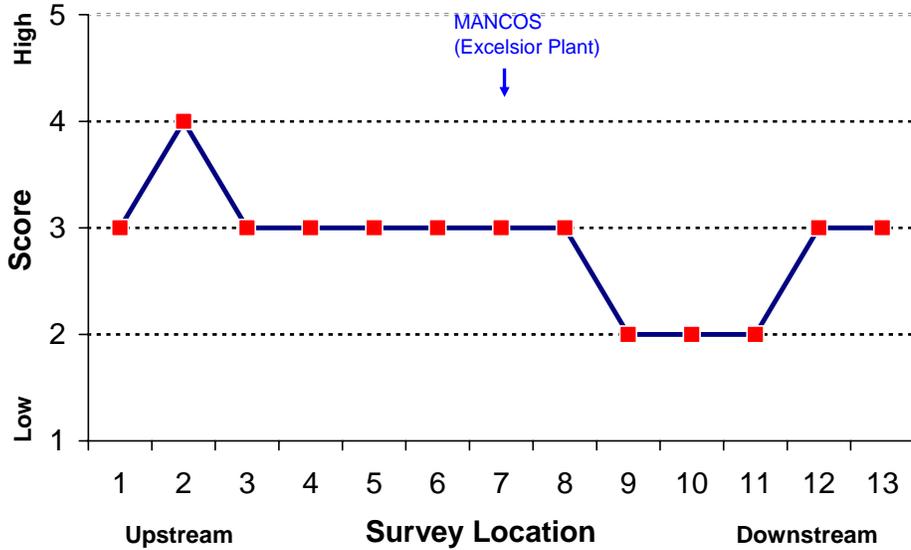
Figure 57. Scores for overall Plant Cover in the Lower Riparian Zone for reaches in the Mancos Valley and adjacent upstream and downstream areas (see text).

The mean cover scores for the lower riparian zone (the zone directly adjacent to the active stream channel) were generally only good, even in the most upstream reaches (Figure 57). Grass cover in this zone was usually less than 70%, except at the reach that was located within the town of Mancos (Figure 59). This was due primarily to the presence of levees in many of the reaches, which were made of cobble and did not provide good growing sites for grasses and forbs. There was also some effect from livestock use in several of the reaches in the lower part of Mancos Valley. Shrub cover in the LRZ was variable (Figure 60), with high values in the upstream tributaries, within the town of Mancos itself, and also after the river entered Mancos Canyon. The low cover values in the reaches just upstream and downstream from the town of Mancos appear to primarily reflect high levels of browsing by native ungulates (primarily mule deer) in these reaches (see Figure 72, below). Middle and upper tree canopy cover in the LRZ were also generally low (Figures 61 and 62), particularly in the lower reaches. The absence of tree cover in much of this area is probably a result of levee construction, combined with past high levels of browsing by both domestic livestock and native ungulates.

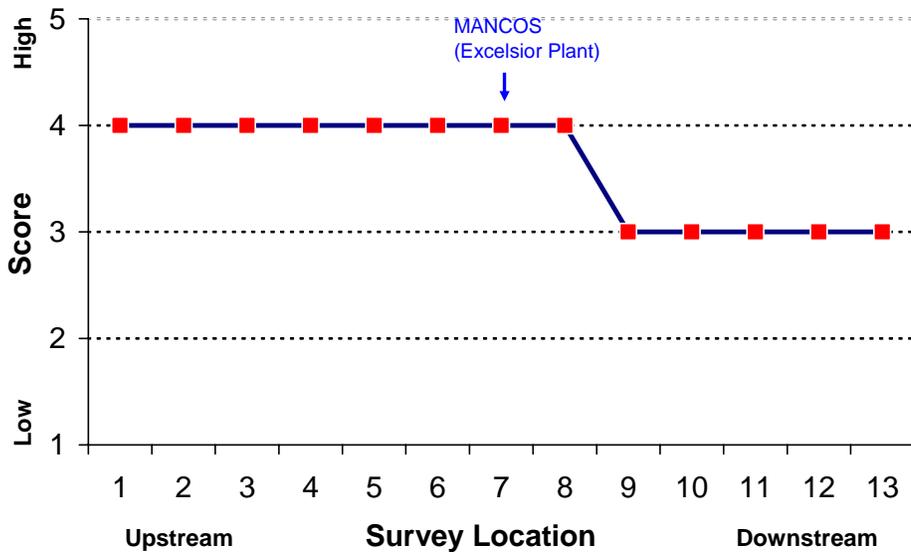
Figure 58. Scores for overall Plant Cover in the Upper Riparian Zone for reaches in the Mancos Valley and adjacent upstream and downstream areas (see text).

Overall scores for vegetation cover in the upper riparian zone (sampled at the edge of the flood plain closest to the stream) were generally better than for the lower riparian zone, reflecting in part the absence of levees in this zone. With the exception of several reaches, the amount of grass and forb cover in this zone was high, and usually 80% or more coverage (Figure 63). Shrub cover (Figure 64) was variable, as in the lower riparian zone, with the highest values in the upstream and downstream reaches, plus within the town of Mancos. Middle and upper tree canopy cover (Figures 65 and 66) was also variable but highest (although still lower than would be expected compared to reference conditions) in the upstream reaches. There were very few middle and upper canopy trees in the lower part of the valley, which again probably reflects heavy past use of the flood plain by native ungulates and domestic livestock. The absence of these trees provides a partial explanation for the low scores for channel shading and solar warming that these reaches received as seen earlier in Figure 42).

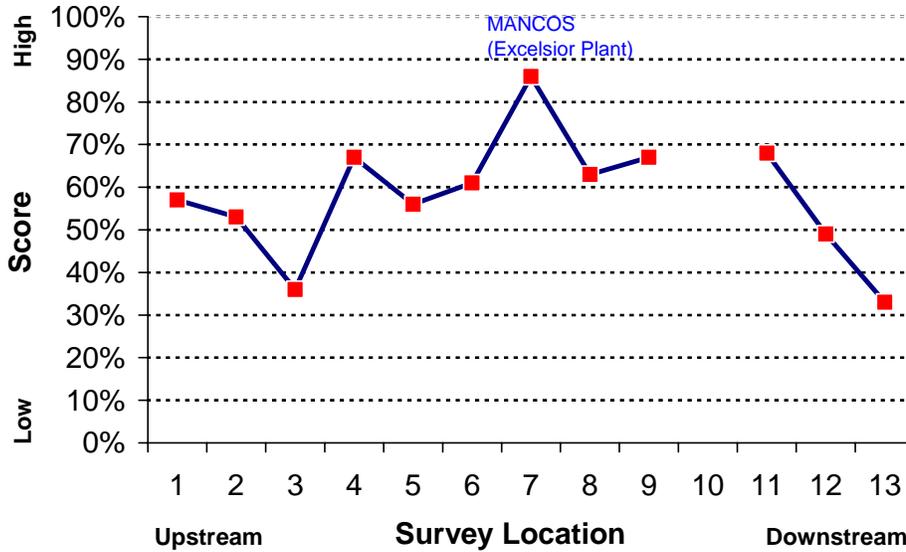
Figure 59. Values for the percentage of area with grass and forb plant cover in the Lower Riparian Zone for reaches in the Mancos Valley and adjacent upstream and downstream areas (see text).

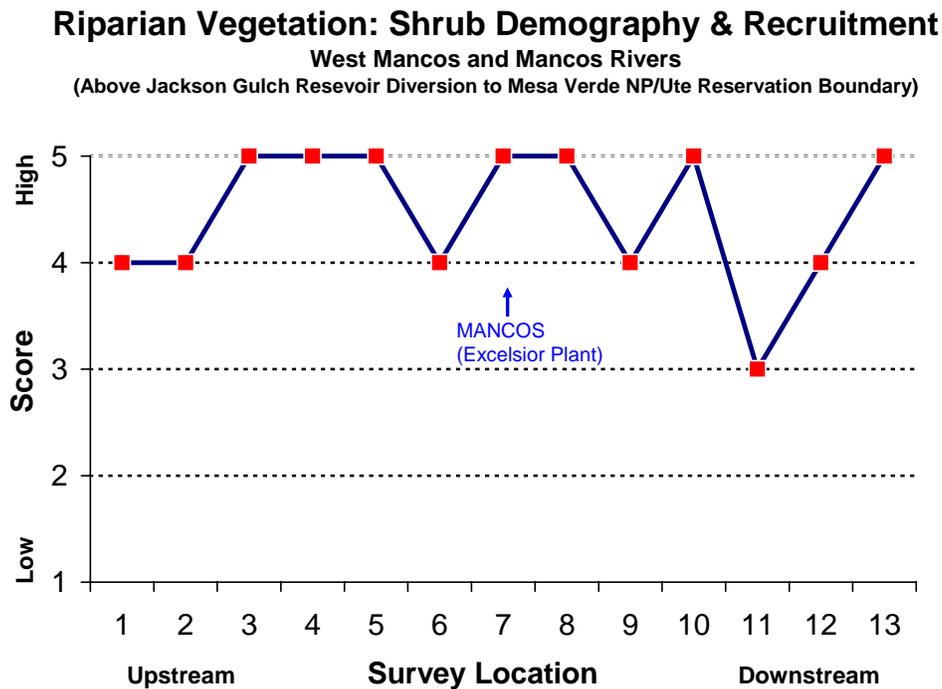
The other variables in Riparian Vegetation section of the RSRA survey examine additional factors that affect the current and future health of the riparian vegetation in both the lower and upper riparian zones. Figure 67 gives the scores for the demographic structure and the recruitment of the dominant native shrub species along each reach, and Figure 68 gives results for the same variables for the dominant native tree species. For the reaches in the Mancos Valley and adjacent areas, the dominant native shrubs were willow and in a few lower reaches, buffaloberry, while the dominant riparian trees in all areas was either narrowleaf or Fremont cottonwood. In order for there to be healthy populations of both woody plant groups in the future, individuals of all age classes should be present in the riparian zone, including seedlings, immatures or saplings, mature individuals, and dead clumps (shrubs) or standing dead snags (trees). When one or more age classes of the dominant species is missing from an area, it indicates that something in the past or something is now disrupting the natural processes of reproduction and individual plant replacement. In time, if that is happening, there may be a complete loss of the species in the area as the older individuals die off and are not replaced by any younger plants.

As shown in Figures 67-68, the scores for native shrub and tree demography and recruitment were generally very good or excellent, and for almost all reaches, either all or all but one of the four ages classes were present. This indicates that there has been ongoing recruitment of shrubs and trees in these reaches for a number of years, and that if current recruitment continues individuals that die off as they age are likely to be replaced by new shrubs and trees. In a few reaches, particularly in some of the more heavily grazed sections, one or more age classes are missing at the current time, and particular attention should be given to the successful recruitment of seedling shrub and trees in these areas for the future (see notes to individual surveys).

Figure 67. Scores for Native Shrub Demography and Recruitment for reaches in the Mancos Valley and adjacent upstream and downstream areas (see text).

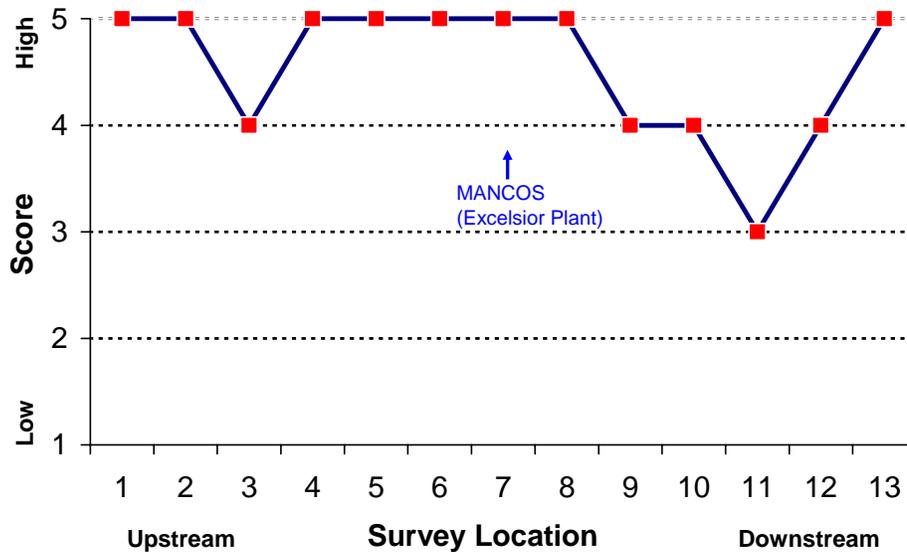
Figure 68. Scores for Native Tree Demography and Recruitment for reaches in the Mancos Valley and adjacent upstream and downstream areas (see text).

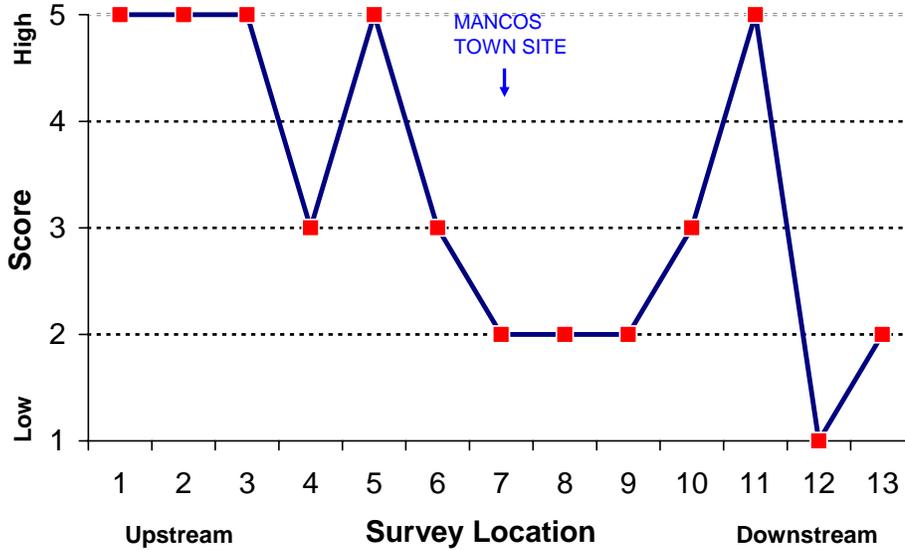
Figure 69 presents the scores for the estimated relative amount of cover within the survey reach that was provided by non-native grasses and forbs, compared to that provided by native species. While non-native grasses and forbs were almost entirely absent in the reaches above Mancos Valley, there were increasing levels of these species as one moved further downstream. Interestingly, non-native grasses and forbs were again almost entirely absent from one of the lower reaches (reach number 11). This was an area where there were no levees lining the channel, and where the stream was naturally meandering. As a result, the riparian soils in this section of the river were very moist and rich in organic matter. This finding suggests, as has been noted elsewhere, that non-native species are most likely to invade a riparian area when the natural hydrological processes and soils have been disturbed.

Figure 69. Scores for relative amount of cover created by Non-Native Grass and Forb species, for reaches in the Mancos Valley and adjacent upstream and downstream areas (see text).
