FUNCTIONAL ASSESSMENT OF THE MANCOS RIVER WATERSHED:

MANCOS VALLEY AND ADJACENT AREAS

PETER STACEY
UNIVERSITY OF NEW MEXICO

Prepared Under Contract with the
Mancos Conservation District
Mancos, Colorado
April, 2007

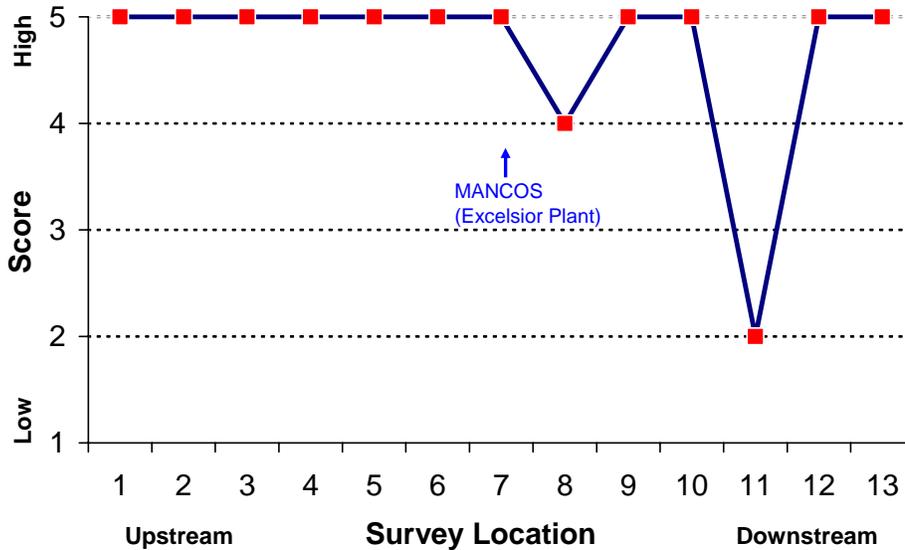
Figure 70 provides the same scores for cover from non-native shrubs and trees. In contrast to most other rivers of a similar size and elevation in the American southwest, there were no or almost no non-native woody plants in the riparian area of the upper reaches, and relative few in the lower parts of the valley as well. There were small numbers of Russian olive and saltcedar in some of the lower reaches, and these populations appear to moving slowly upstream. Saltcedar had been actively removed from the reach in Mancos Canyon by Mesa Verde National Park, and additional removal programs currently underway or planned within the Valley may halt or slow this invasion. However, the small numbers of non-native

Figure 70. Scores for relative amount of cover created by Non-Native Shrub and Tree species, for reaches in the Mancos Valley and adjacent upstream and downstream areas (see text).

woody species present throughout Mancos Valley at the current time is exceptional, and is probably due at least in part to the moist soils and well-developed native riparian vegetation in much of the flood plain that results from the leakage of water from the irrigation ditches within the valley.

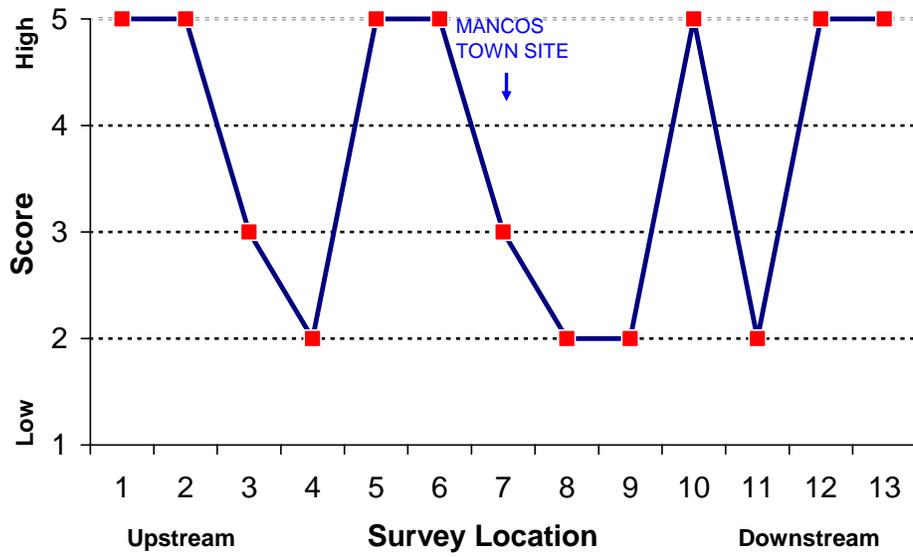
Figure 71. Scores for extent of Mammalian Herbivory, or grazing impacts on ground cover (grasses and forbs) in the lower and upper riparian zones for reaches in the Mancos Valley and adjacent upstream and downstream areas (see text).

The final two variables in this section examine the impacts of large mammal use of vegetation in the upper and lower riparian zones. Figure 71 presents the scores for the level of grazing on grasses and forbs in both zones, as determined by the percentage of samples in the survey transect where the plants had been clipped off, compared to those samples where there was no evidence of clipping (see the RSRA User’s Guide for a discussion of the survey protocol). Most of the grazing in the riparian zone within the Mancos Valley is done by domestic livestock, although deer and elk may also graze occasionally in some reaches, particularly in areas outside the valley. Intense levels of grazing can affect the condition of ground cover, encourage the invasion of exotic species, lead to increased soil compaction and erosion, and change overall ecosystem function. As seen in Figure 71, grazing impacts were highly variable among the survey reaches, with high rates of grazing seen primarily in areas where the reach was part of an active domestic livestock pasture. The level of grazing in these pastures was having a negative impact upon the health of the riparian ecosystem in those reaches, and the planned exclusion of livestock from the riparian corridor in several of these reaches will clearly be beneficial.

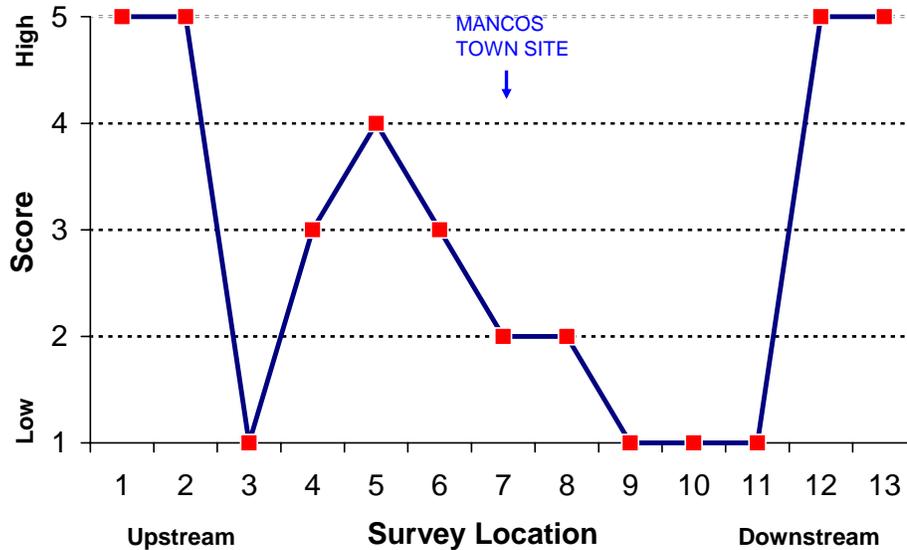
Figure 72. Scores for extent of Mammalian Browsing impacts on woody vegetation (shrubs and small trees) in the lower and upper riparian zones for reaches in the Mancos Valley and adjacent upstream and downstream areas (see text).

The second major impact of large mammals on riparian vegetation is when the animal eats, or browses, the end or the growing tip of the branches of woody plants, including both shrubs and small trees. Browsing can affect the health of these plants by stopping the future growth of the branch that has been eaten, and continued high levels of utilization will eventually result in the death of the plant. Over time, this can cause the loss of all shrubs and trees in a local area, a situation that is commonly seen in many of the riparian areas in the American southwest and elsewhere. Figure 72 presents the scores for mammalian browsing, as determined by the percentage of shrubs and small trees that showed evidence of clipping at the tips of the branches somewhere on the plant, relative to those that did not show such evidence (see the RSRA User’s Guide for a discussion of the survey protocol). Browsing impacts were again highly variable among reaches, with very little browsing seen in the two upper and two lowest reaches, and high rates of browsing observed in the reaches around and downstream from the town of Mancos. Although we did not directly attempt to determine the specific mammal species that were responsible for the heavy browsing levels in these reaches, a number of the most impacted reaches were located in areas where there was no evidence of current domestic livestock use. In addition, we frequently encountered mule deer while conducting the surveys, particularly in areas that were close to the town of Mancos. This pattern suggests that deer are the major browser at the present time, although domestic livestock may also eat some woody vegetation, particularly when other foods are scarce. The level of browsing that was observed in the most impacted reaches is sufficient to influence the future recruitment of woody vegetation in those areas, and if continued may lead to the loss of most or all of the shrubs and trees in those areas.

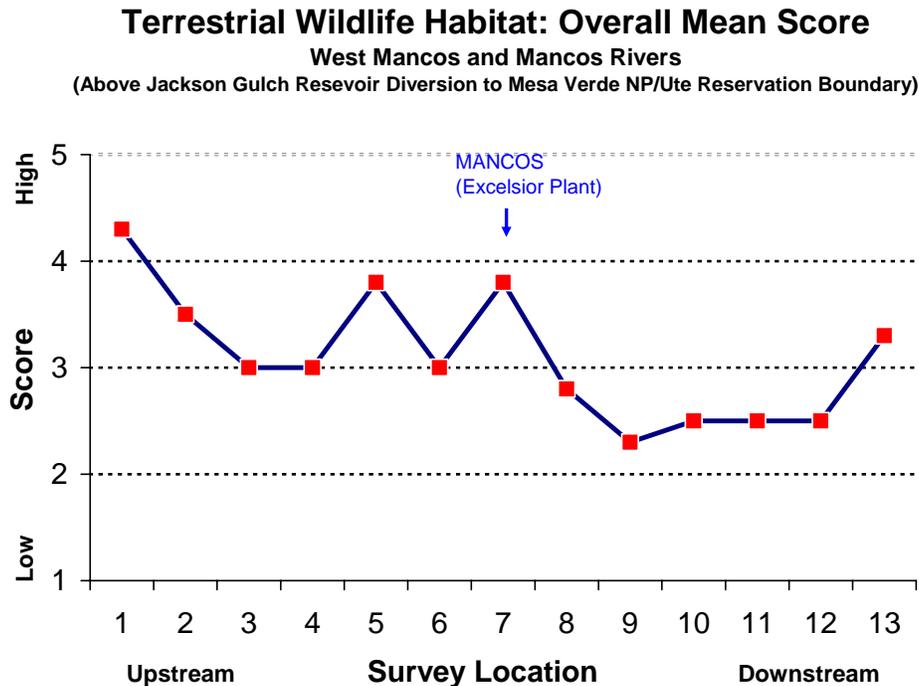
Figure 73. Mean scores for the Terrestrial Wildlife Habitat survey variables for reaches in the Mancos Valley and adjacent upstream and downstream areas (see text).

Figure 73 gives the mean scores for the Terrestrial Wildlife Habitat variables. Overall, the reaches above the town of Mancos scored as having good or better habitat for terrestrial wildlife, while habitat quality declined in the lower parts of Mancos Valley, although the habitat began to improve again as the river moved into Mancos Canyon.

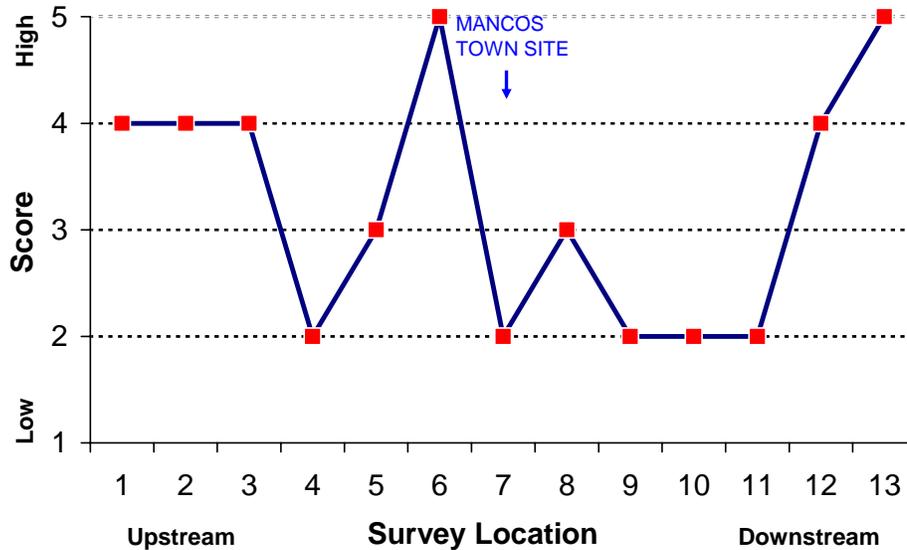
Figure 74. Scores for Shrub Patch Density for reaches in the Mancos Valley and adjacent upstream and downstream areas (see text).

longer be able to breed or survive in the impacted areas. As shown in Figure 74, the density of shrub patches (primarily willows) was very good or excellent in some reaches, but such patches were almost entirely absent in other reaches, particularly in the lower parts of Mancos Valley. These reaches would not be suitable habitat for species that depend upon such patches, like many duck species that need dense willows to hide their nests from predators. However, seedling shrubs are now growing in many of these areas (Figure 67, above). This suggests that these areas can improve as wildlife habitat with appropriate management of both the wild ungulates (deer and elk) and of domestic livestock, as well as the maintenance of the moist soil conditions that allow for seed germination and vigorous plant growth within the flood plain.

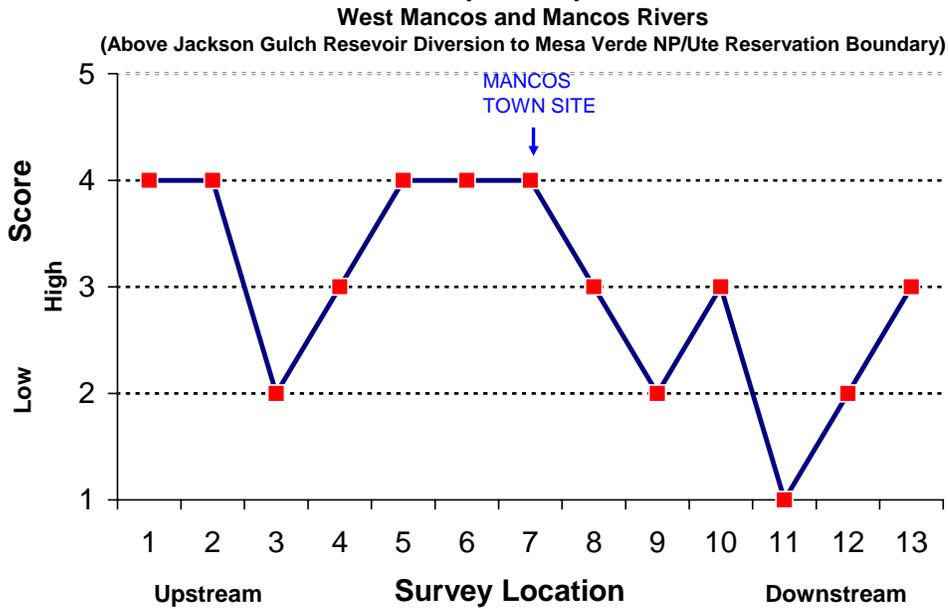
Figures 75-76 give the scores for patch density and connectivity in the Middle and Upper Canopy tree layers. Reaches above the town of Mancos generally score high on these two variables, while those below the town scored lower. In some reaches, there were only isolated individuals of middle and upper canopy trees, and as a result, there were no patches of this type of vegetation. These reaches would not be suitable habitat for the wildlife species that require dense habitat patches in these two layers. In other reaches, patches of one layer were present, but none of the other layer (e.g., reach number 6). This type of variation is usually the result of past land use practices on that particular reach: for example, seedling recruitment may have occurred during one period in the past, but may have ended at a subsequent date when the use of the reach changed. As a result, there might be a number of large trees present along the stream in that area, but no mid-sized individuals (or visa versa). However, as with the shrub component, there were seedling cottonwoods present in almost all of the reaches in Mancos Valley and the adjacent areas. This again suggests that these components of wildlife habitat will improve in the future with appropriate management of native and domestic ungulates, and the maintenance of a healthy flood plain.

Figure 75. Scores for Middle Canopy Tree Patch Density for reaches in the Mancos Valley and adjacent upstream and downstream areas (see text).

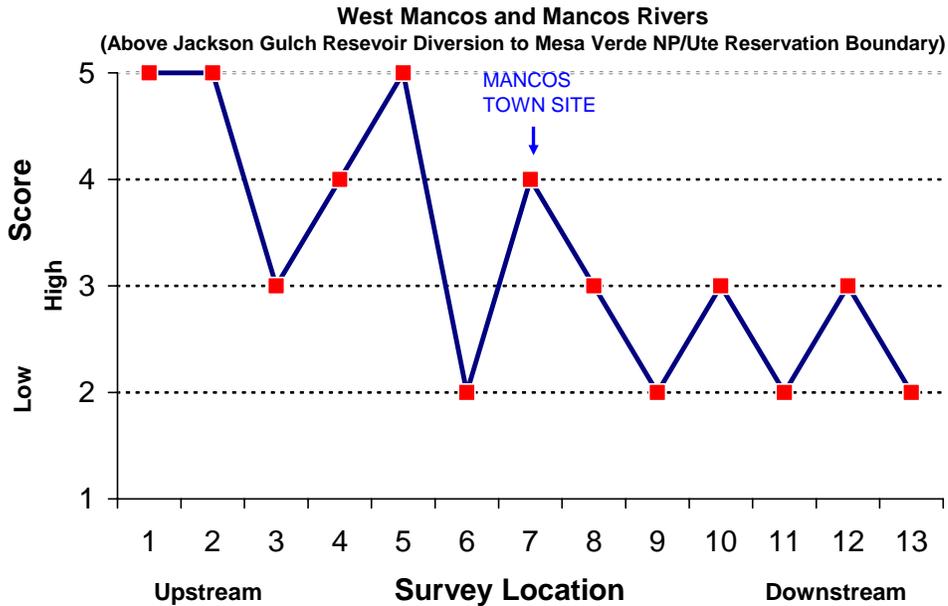
Figure 76. Scores for Upper Canopy Tree Patch Density for reaches in the Mancos Valley and adjacent upstream and downstream areas (see text).

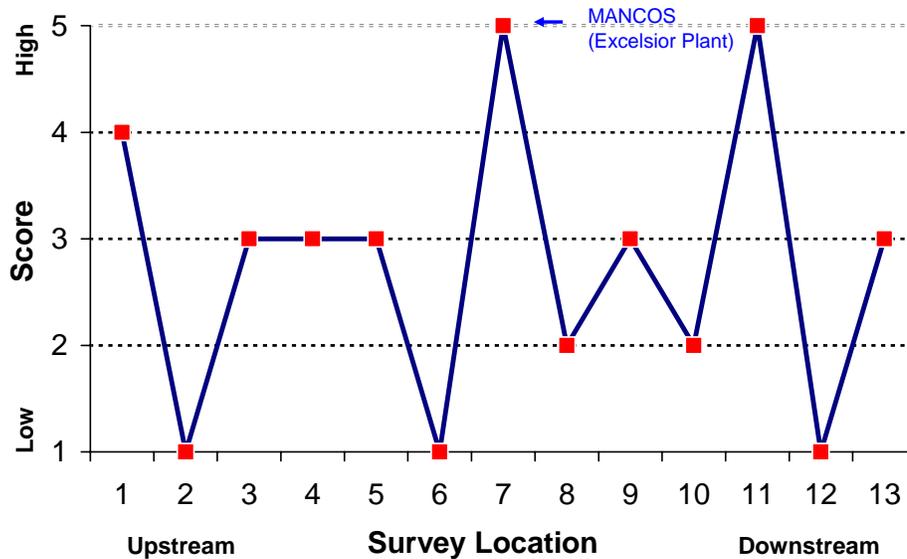
Figure 77. Scores for Fluvial Habitat Diversity for reaches in the Mancos Valley and adjacent upstream and downstream areas (see text).

The final component of wildlife habitat section is shown in Figure 77, which gives the scores for the diversity of fluvial, or above-water, habitats within the stream and flood plain on each reach. Natural hydrological, geological and ecological processes create a variety of fluvial landforms, including terraces, bars, oxbows, wet marshes, and fluvial marshes, which provide the habitats needed by many different species of terrestrial riparian wildlife. For example, Spotted Sandpipers (*Actitis macularia*) will only nest in stream-riparian habitats with exposed sand or gravel bars, and northern leopard frogs (*Rana pipiens*) normally occur only in areas with standing water such as marshes and ponds. In contrast, in highly degraded systems with extensive erosion and downcutting, there may be only a single fluvial landform: a straight and single-depth channel, steep sided banks without vegetation, and a flat and dry flood plain. Many species of terrestrial wildlife that may have been originally present along the reach may be unable to reproduce or survive under those conditions. As seen in Figure 77, the scores for fluvial habitat diversity varied widely throughout the survey area, from excellent (high diversity) to poor (no diversity). This variation occurred even between adjacent reaches (reach numbers 6 and 7, as well as numbers 11 and 12). The lack of diversity of fluvial habitats generally was the result of the past channelization of the stream within a reach, along with the presence of levees that has prevented new channel meandering and overbank flooding. In many of the reaches, some of the fluvial habitats that were present, for example, many of the wet meadows, marshes, and backwaters, were the direct result of water flows from the irrigation ditches in the upland areas adjacent to the flood plain.
